NATIONAL TRANSPORTATION SAFETY BOARD

Report No. 99-74

SEQUENCING GROUP STUDY ON EXPLOSION OF CENTER WING FUEL TANK OF A TEST AIRPLANE

Place : East Moriches, New York
Date : July 17, 1996
Vehicle : Boeing 747-131, N93119
NTSB No. : DCA96-M-A070
IIC : Al Dickinson, AS-10

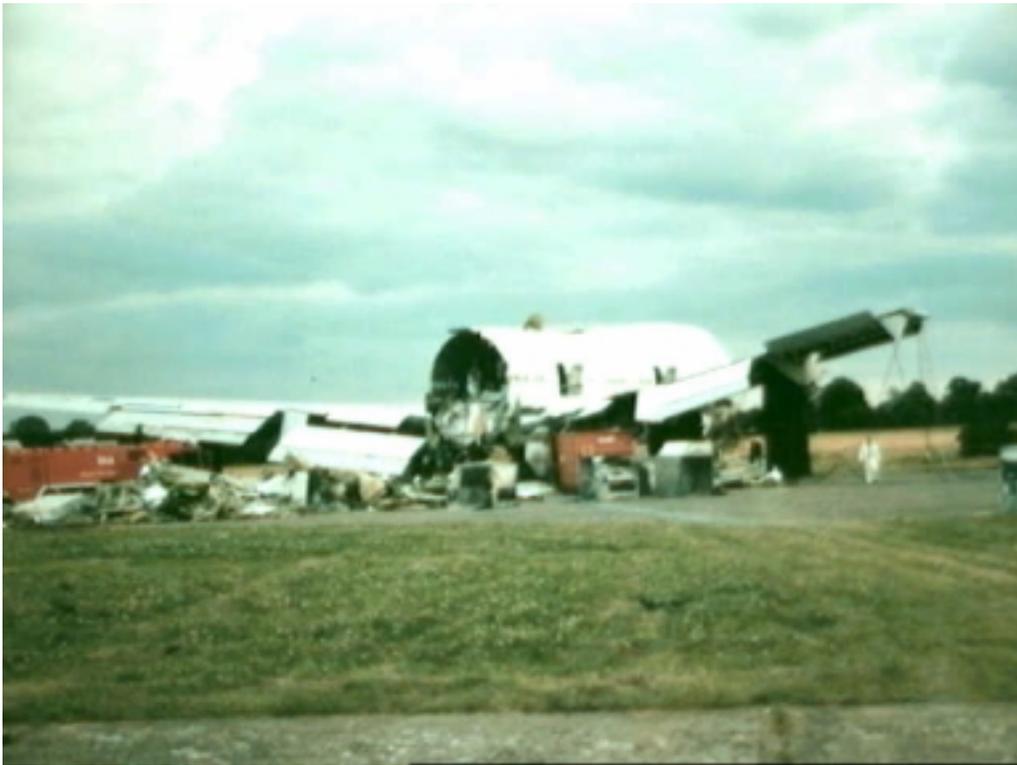
5. CLOSE-UP VIEW OF THE TEST SET-UP AFTER EXPLOSION

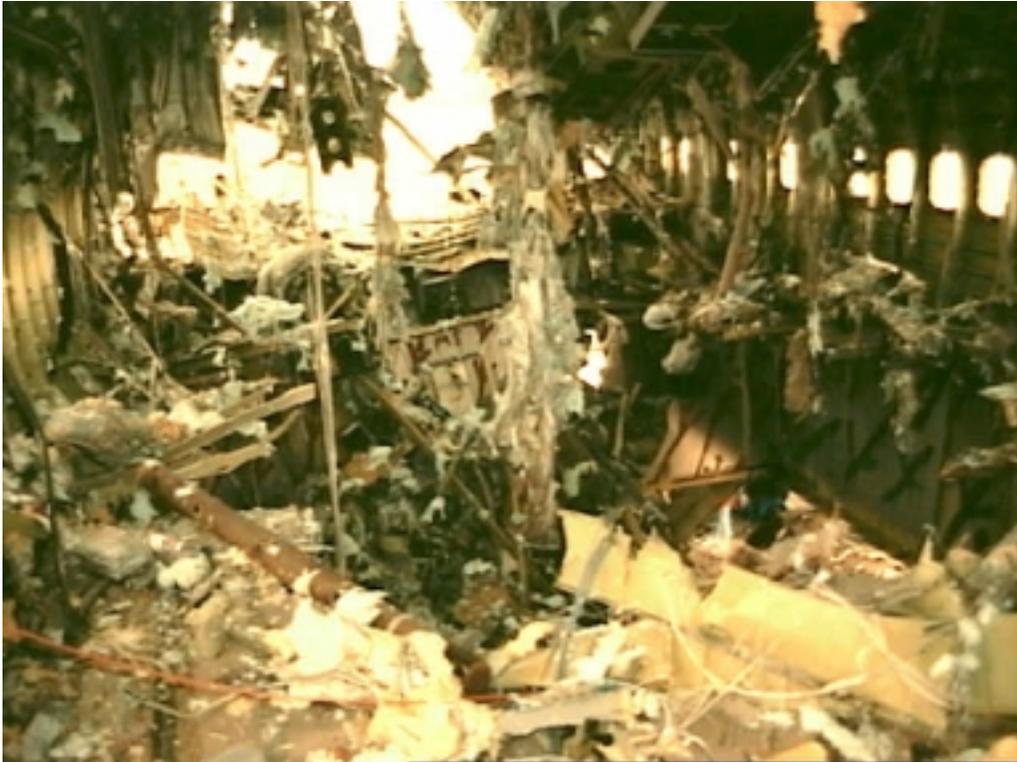
6. VIEW SHOWING DAMAGE OF WING CENTER TANK AFTER EXPLOSION

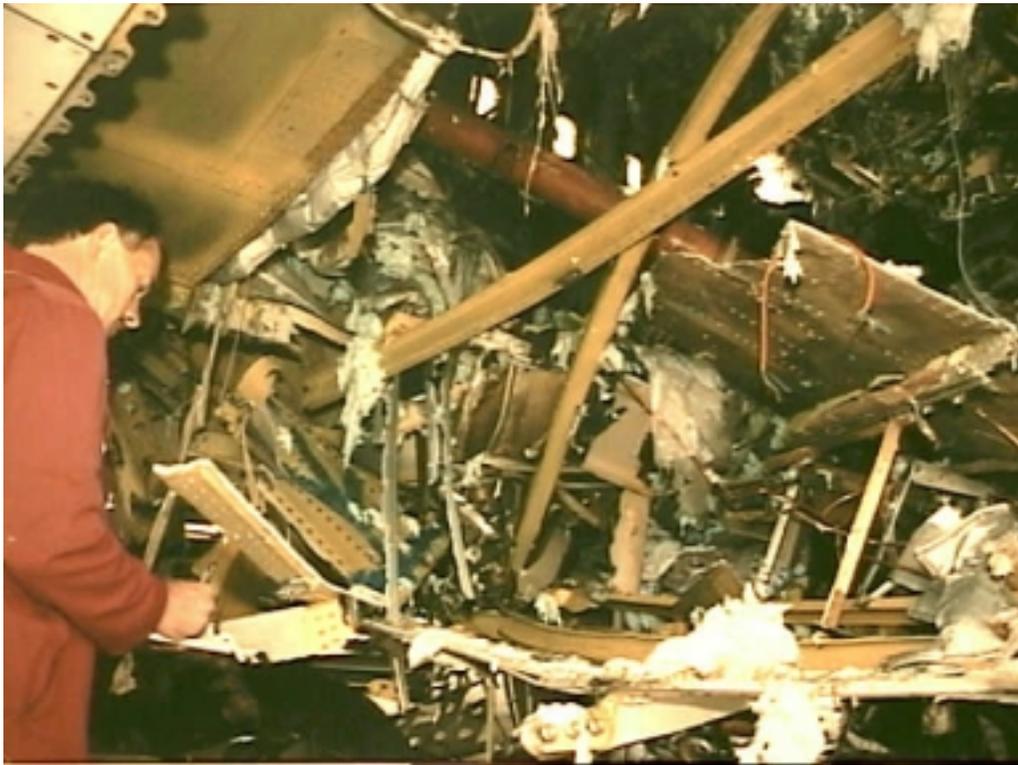
7. CLOSE-UP VIEW OF THE DAMAGE TO WING CENTER SECTION

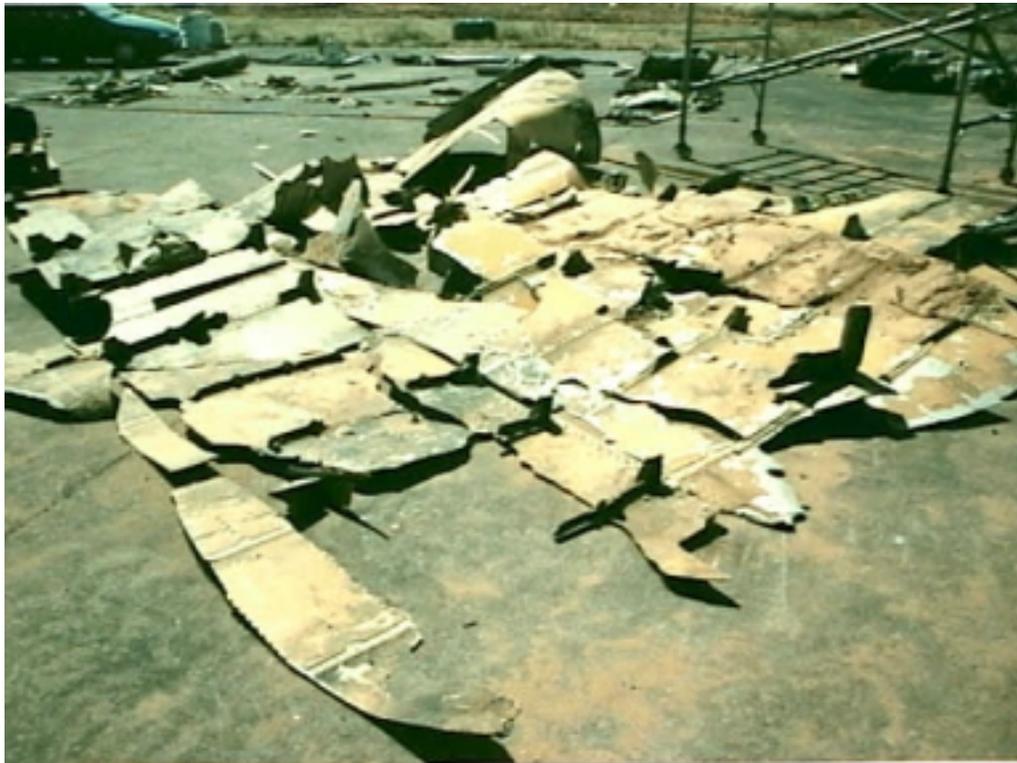
The upper panel of the WCS was broken into approximately 35-40 pieces ranging in size from less than one square foot to one large piece that extended almost to each side of body rib and from spanwise beam No. 1 (SWB1) to the rear spar.

8. VIEW SHOWING DEFORMATION OF THE UPPER SKIN

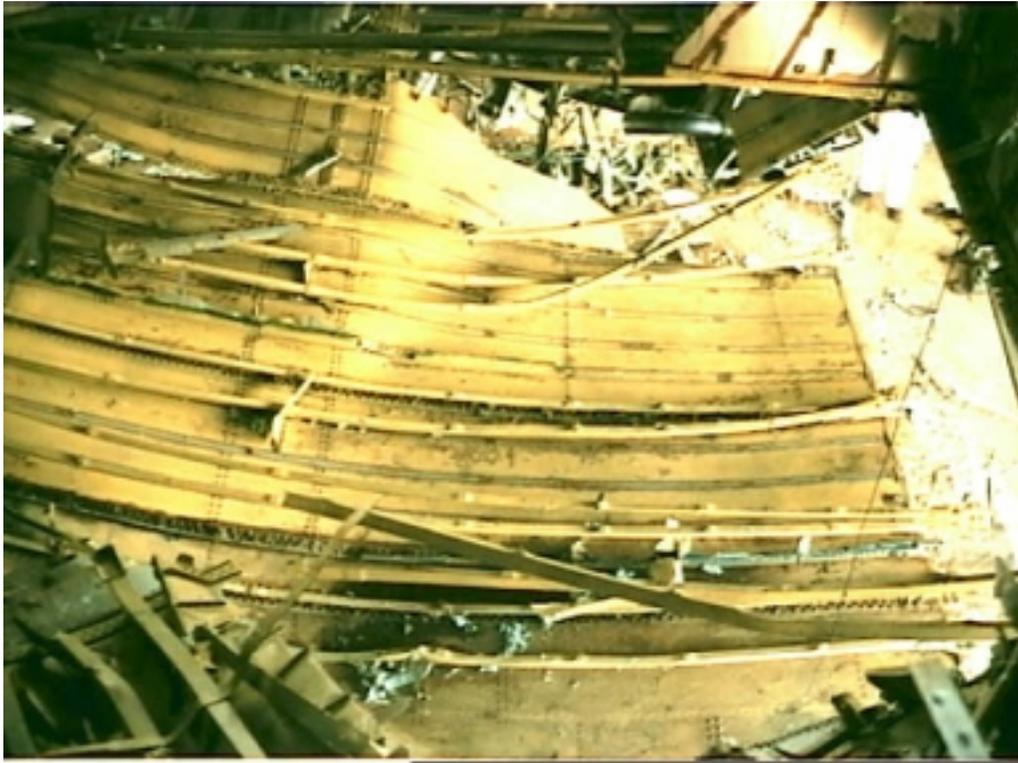
The entire lower skin panel remained attached to the airplane along at least one edge but had internal fractures separating the lower panel into 3 major portions:

9. VIEW SHOWING DEFORMATION OF THE LOWER SKIN

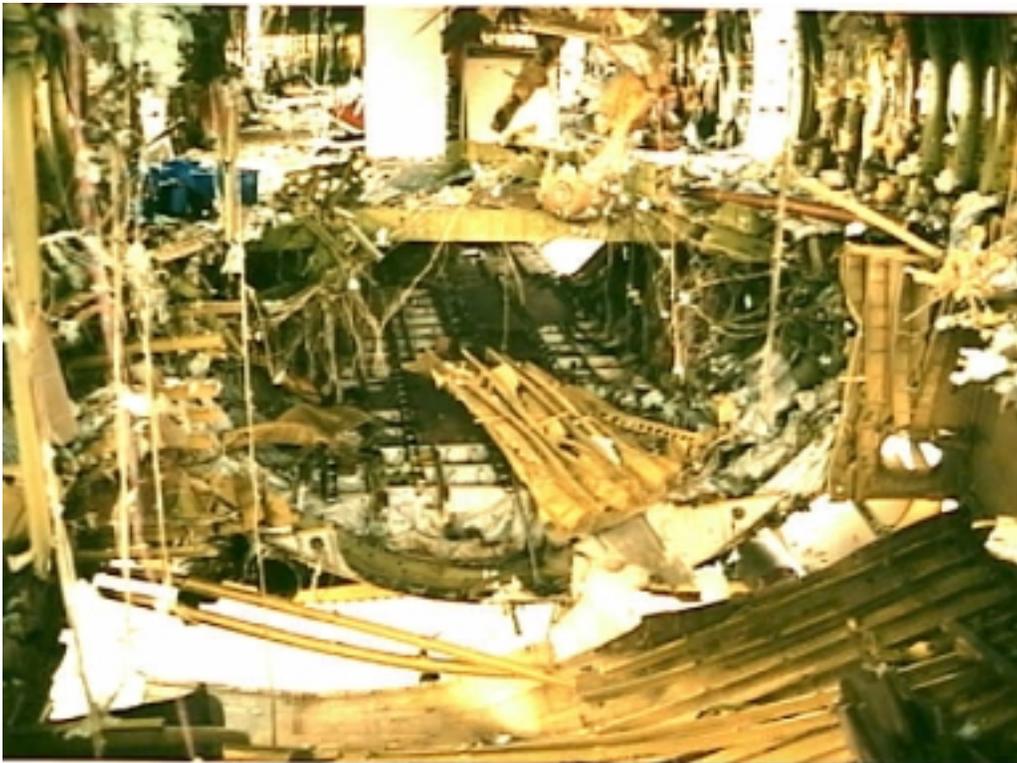
The WCS front spar separated into 6 major sections. The portions from LBL 94 to the LSOB and from RBL 87 to the RSOB remained attached to the aircraft and were heavily bent forward on the inboard edges and wrapped around the fuselage ring chord. Compression damage to the fuselage skin panel (see 4.2.14) attached to the ring chord was consistent with the ring chord being forced forward. Another major portion on the right side extended from LBL 20 to RBL 66 and was rotated forward and was found lying in the forward cargo compartment just forward of its original location. The right potable water tank was still attached to this front spar section and was crushed. Another section of the front spar extended from RBL 66 to RBL 87.

10. VIEW SHOWING SECTIONS OF FRONT SPAR PUSHED FORWARD

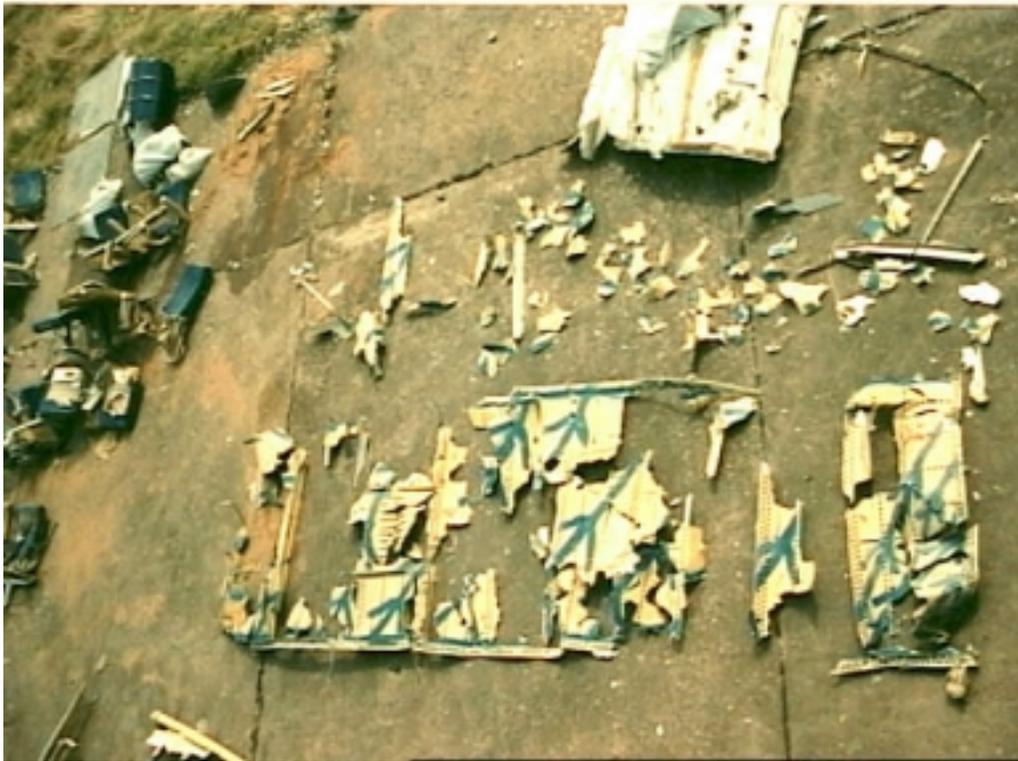
The LBL 9 lower tension fitting remained attached to the beam, and the tension bolt hole had elongation on the forward side of the hole. There were three lower stiffener shear ties recovered that exhibited hole elongation on the forward side of the hole. At nine shear tie locations on the lower panel, shear tie fasteners still remained in the lower skin panel. These fasteners showed some small forward/aft deformation but were relatively straight. There were five recovered upper chord shear ties. The upper skin to shear tie fasteners exhibited head tension failures and the bolt shanks remained straight. The floor beam tension bolt in the SWB3 tension fitting at LBL 33 and 57 showed tension failure with some inward bending. The shear tie fastener holes in the upper skin panel showed forward elongation and witness marks at the majority of the bolt holes, consistent with the upper edge of SWB3 moving forward.

11. VIEW SHOWING DEFORMATION & DAMAGE TO SWB#3

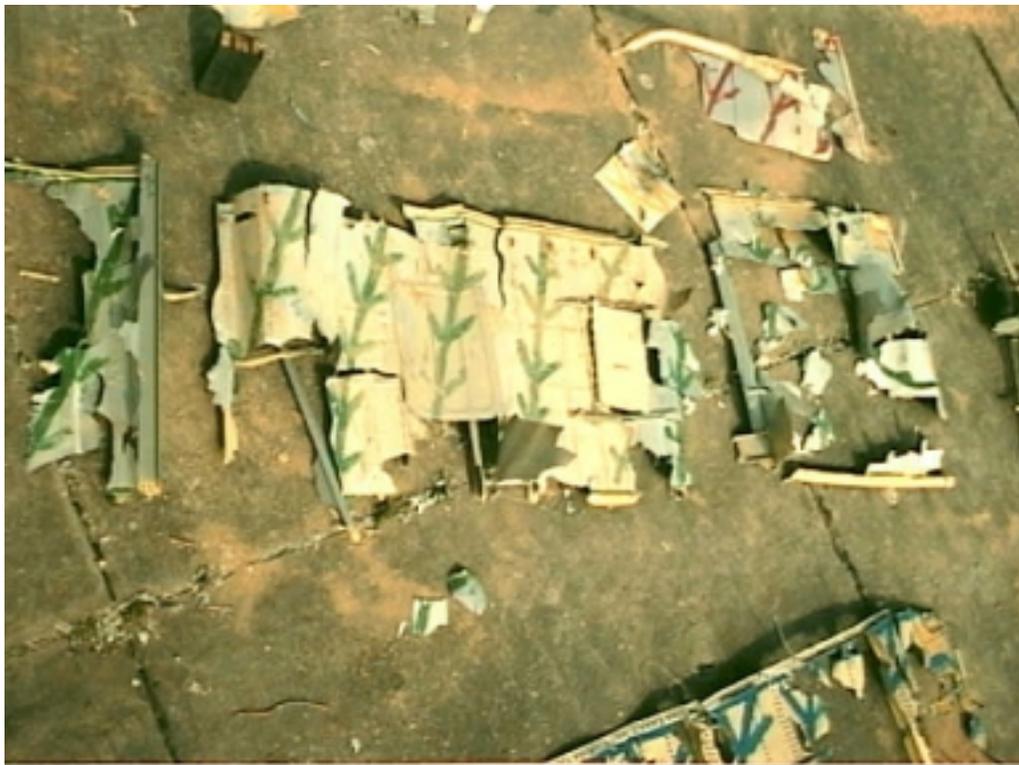
SWB2 was generally broken into a large number of small pieces, especially between LBL 34 and the LSOB. No evidence of overall bowing in the pieces was found. Most pieces of the left side of SWB2 were found forward of the beam location, including some in the forward cargo compartment. A few pieces were found aft of the beam, including a large piece from the center (item 105) that was found lying on its aft side with the lower chord approximately in its proper location (STA 1100). Approximately 28 percent of the spanwise beam 2 pieces were recovered from the forward cargo compartment.

12. VIEW SHOWING DEFORMATION & DAMAGE TO SWB#2

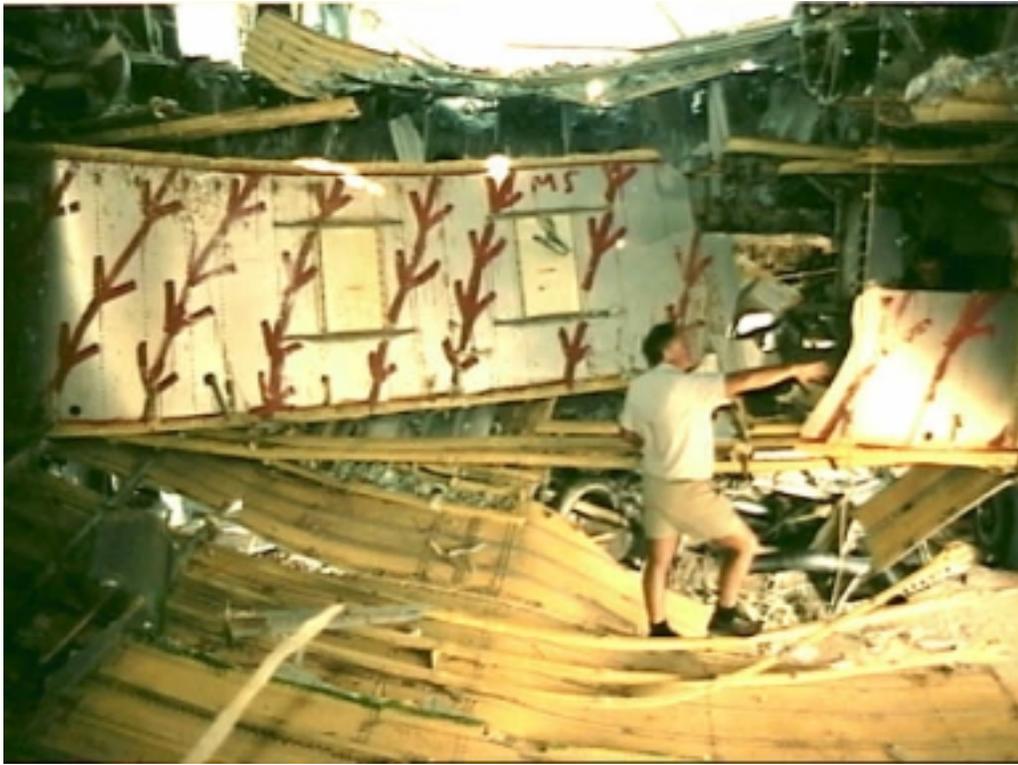
The largest piece of the midspar (about LBL 57 to RSOB) remained in the tank and was displaced aft about 3.5 feet. This section remained attached to RSOB, and the upper end of the spar was tilted aft approximately 30 degrees at LBL 57. This piece of the midspar was relatively undeformed from RBL 95 to the RSOB. The remaining portion of the web was bowed in the aft direction over most of its length, with the most aft portion of this bowing located approximately at BL 0. Associated with the bowing in the aft direction was a fracture in the upper chord of the spar at RBL 95 and a fracture in the lower chord at RBL 69. The aft bowing in the midspar was inboard of these fractures.

13. VIEW SHOWING DAMAGE TO MID SPAR

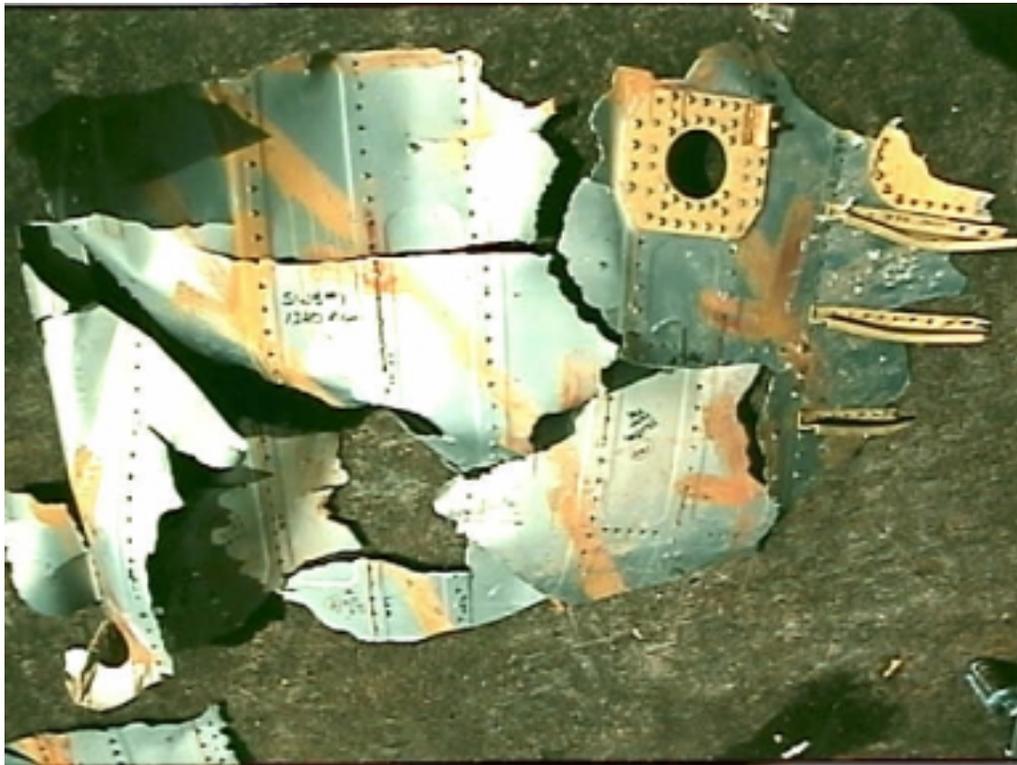
SWB1 separated into approximately seven large sections and numerous small sections. The upper chord fractured at RBL 98 and LBL 106. Mainly the lower portion of the web and the horizontal stiffeners remained attached from RSOB to RBL 106. Approximately four to twelve inches of lower web remained attached to the lower chord from the LSOB to the RSOB.

14. DEFORMATION OF SWB#1

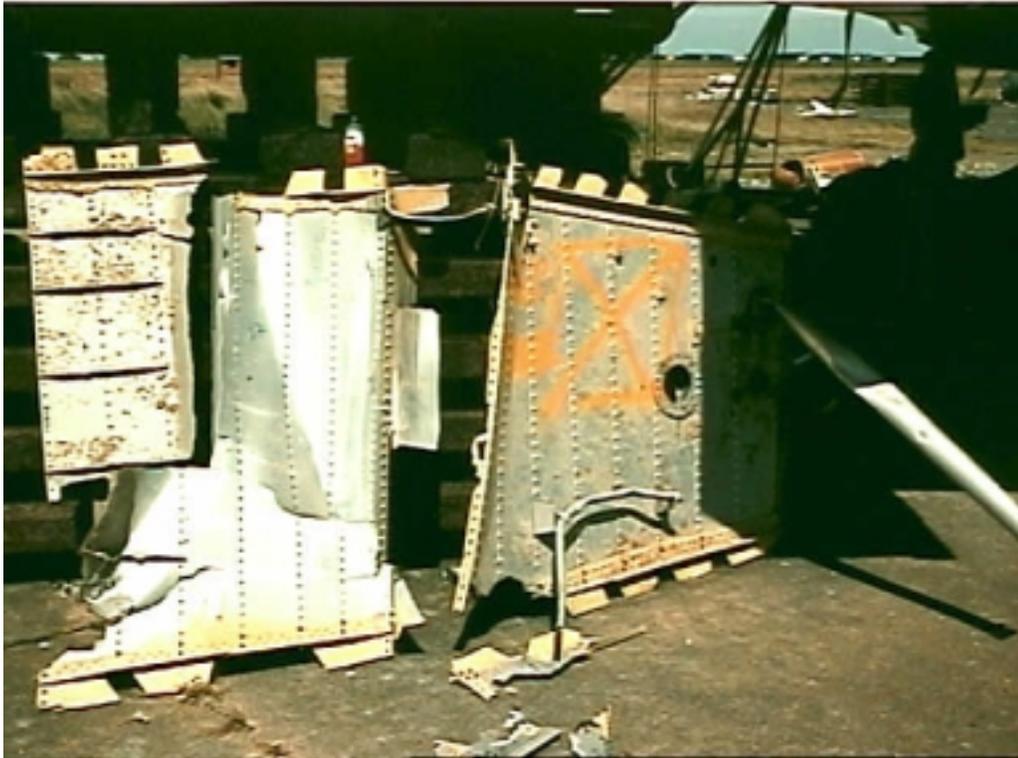
This segment of the BL 0 rib broke into three large pieces (items 148, 149, and 151). These pieces show general bowing to the right consistent with an overpressure in that direction. The upper chord and the lower chord skin attach flanges were partially or totally separated (remained on skin panels). The upper chord was fractured midway between SWB1 and the midspar. The lower chord was fractured at the same location. The web crack ran from the same location as the upper chord crack and the

15. DEFORMATION AND DAMAGE OF B.L.0 RIB

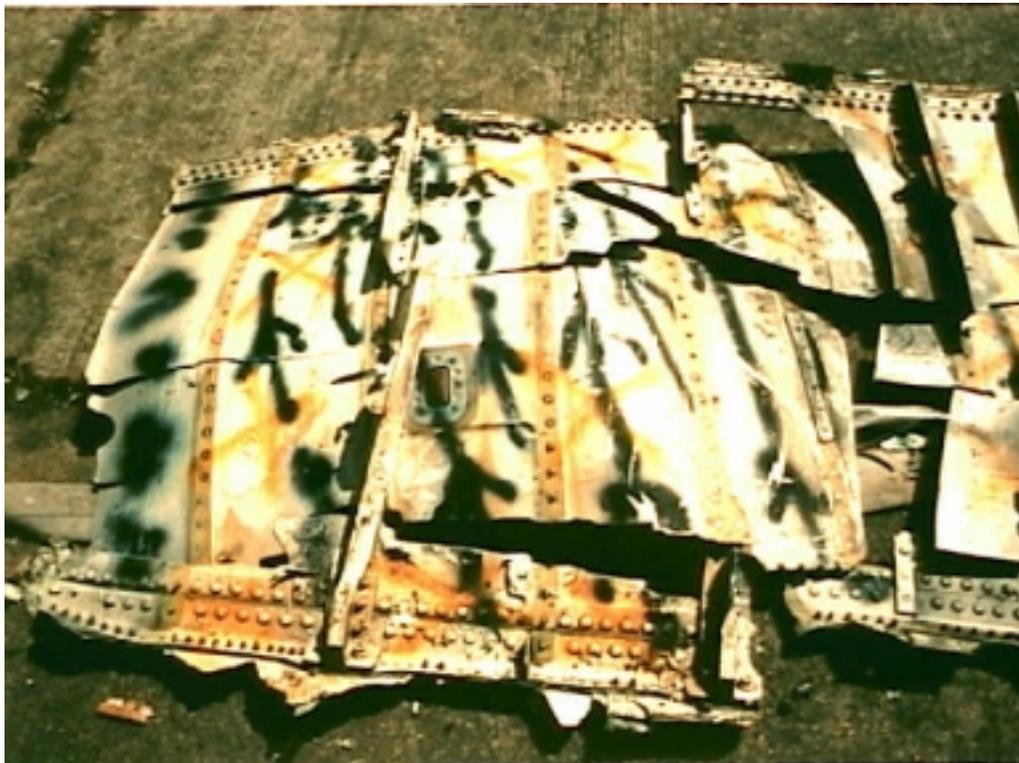
From LBL 11 to LBL 98 the rear spar broke into six pieces. All of these pieces (items 3, 354, 355, 357, 351, 356, and 361)³ were found near the center wing fuel tank area on the ground. The stiffeners on these pieces were either separated or cracked. Assembly of the web pieces formed a dome shape in the aft direction centered at LBL 45.6 and midway between the upper and lower chords. The upper chord and lower chord web attach flanges remained attached to these pieces.

16. DEFORMATION OF REAR SPAR

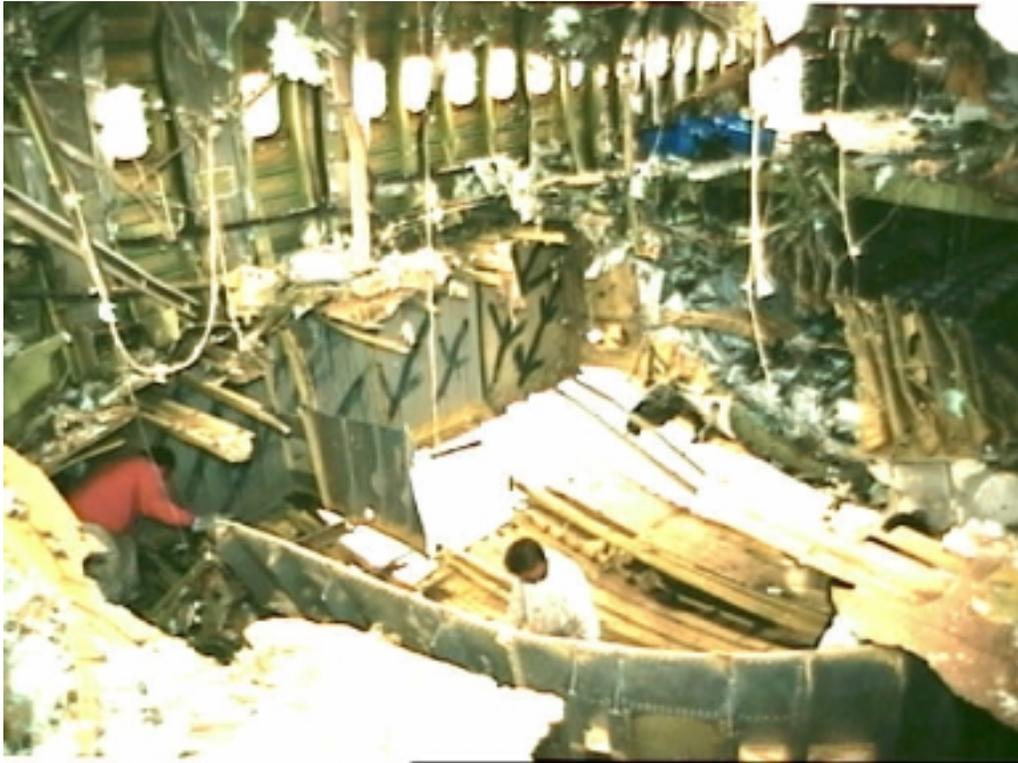
The RSOB remained intact from the rear spar to the midspar. The lower chord vertical flange from the midspar to the front spar was cracked in the radius and remained attached to the RSOB (the skin was bowed down approximately twelve inches at SWB3). There was a web crack that ran vertically between twelve to sixteen inches aft of the front spar from six inches above the lower edge of the web to twenty-four inches below the upper edge of the web, intersecting another crack from the front spar aft and up to the SWB3 upper chord. The double plus chord web attach flange radius contained a crack that ran aft to approximately fourteen inches aft of SWB2.

17. VIEW SHOWING DAMAGE TO RSOB RIB

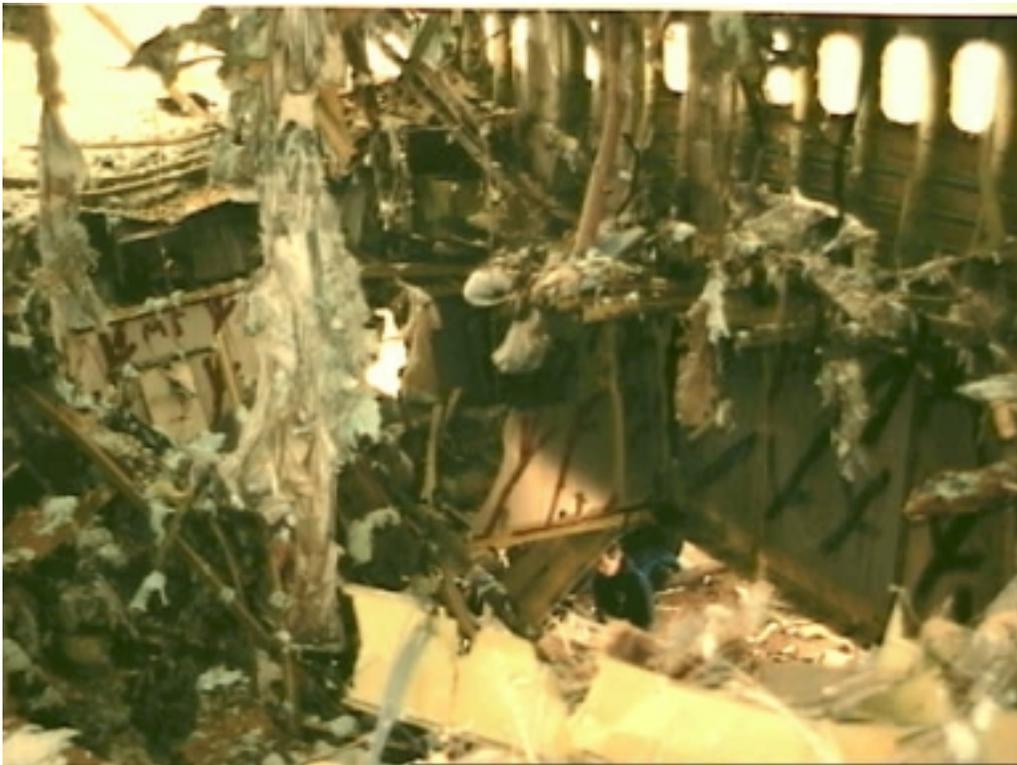
The LSOB remained intact from the midspar to the rear spar. There was a web crack starting from the lower chord running up and aft approximately fourteen inches to the midspar attach stiffener. It ran up through the forward fastener holes and ran forward at about twenty inches below the upper chord at a 45 degree angle to the upper edge of the web. Fasteners common to the upper web and double plus chord aft of SWB2 failed in combined tension and shear. From SWB2 to the front spar, the double plus chord attach flange was fractured. The lower chord of LSOB was undamaged. The LSOB web between the midspar to the front spar was generally displaced outboard approximately three inches along the cracked edge only. There was also outward bowing of the web indicative of an outward acting overpressure. The web and stiffeners between SWB2 and the front spar were generally straight. The midspar web attach flange was separated approximately ten inches above the lower edge. The SWB2 web attach flange remained attached from the bottom to approximately 25 inches below the upper end. It had a distinct buckling wave also

18. VIEW SHOWING DAMAGE TO LSOB RIB
