**DOCKET NO. SA-516**

**FIRE AND EXPLOSION GROUPS FACTUAL REPORT**

TWA FLIGHT 800 ACCIDENT INVESTIGATION

**APPENDIX III**  
**TESTS AND ANALYSIS RESULTS**

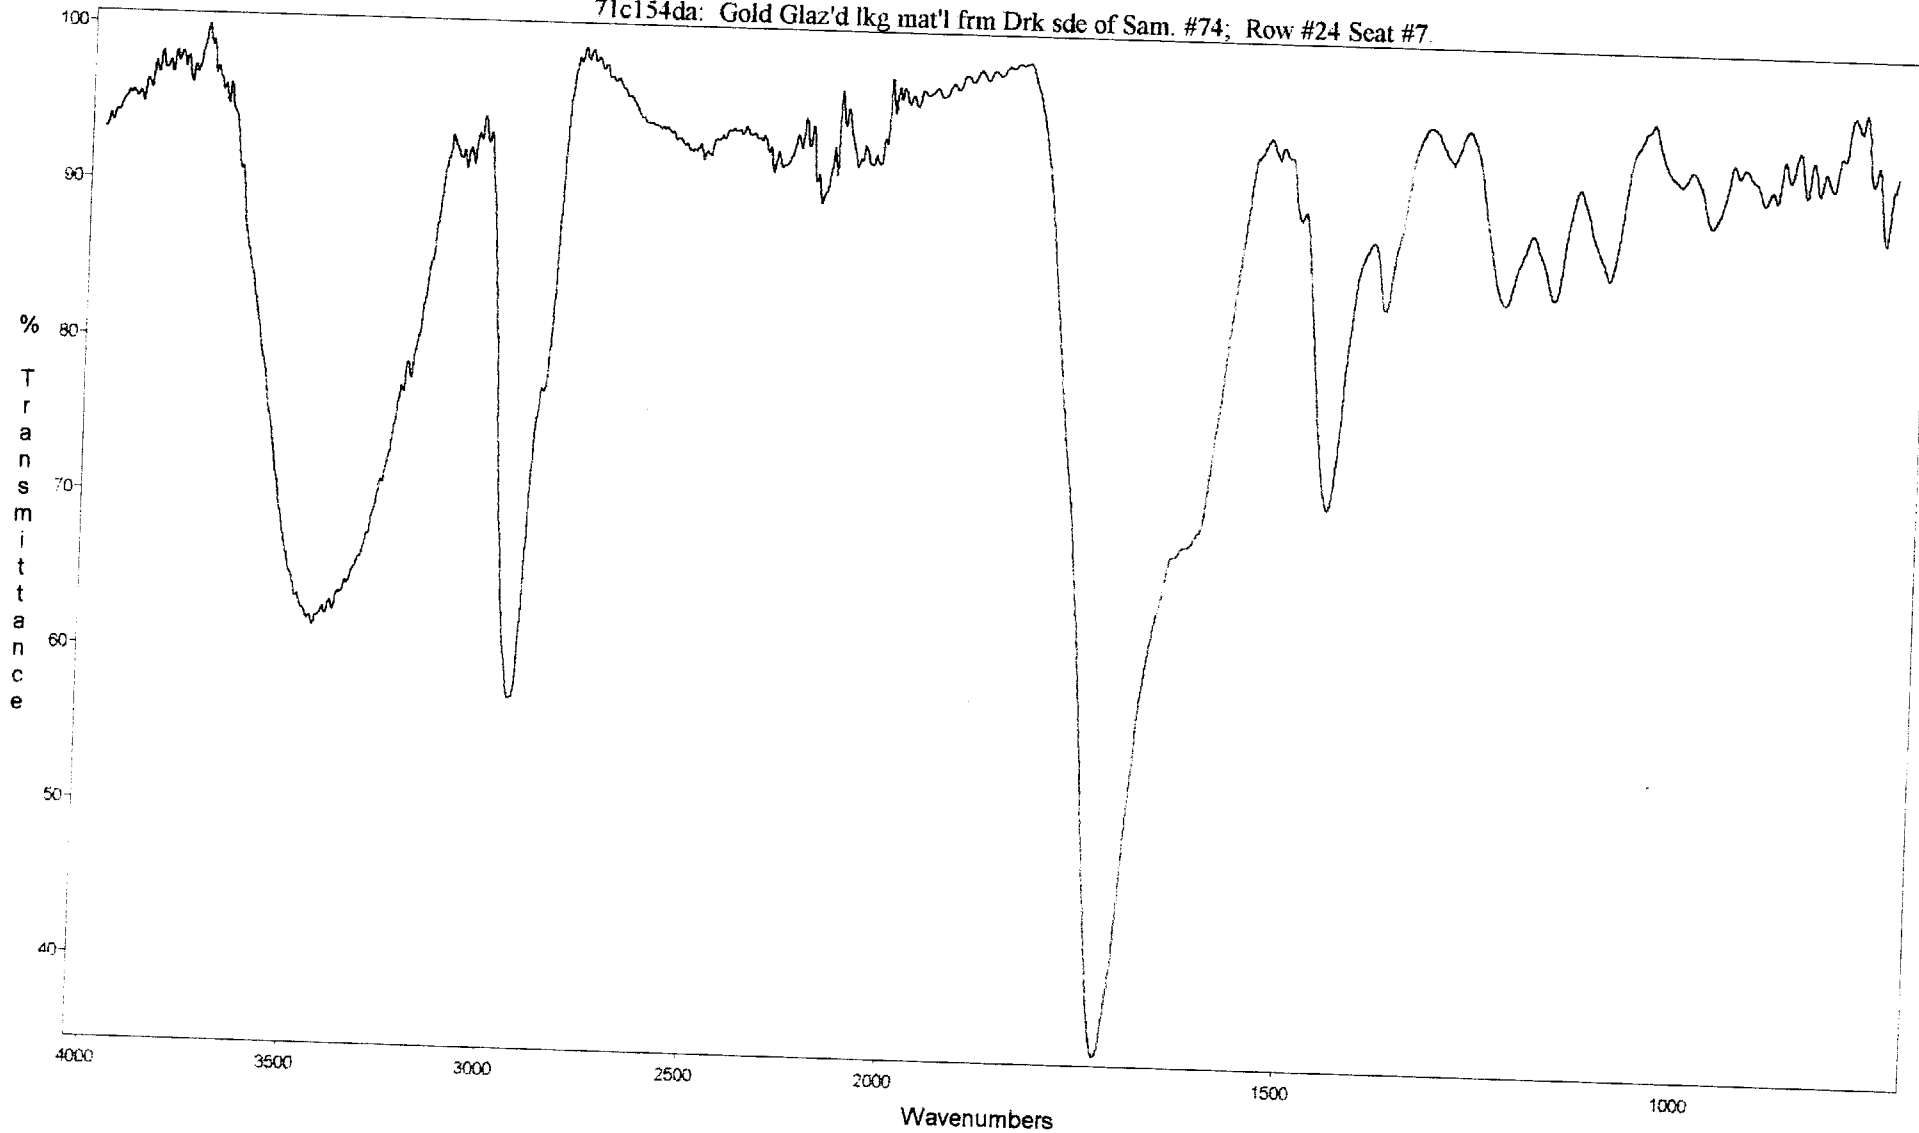
- 4.5 The gold glazed looking material removed from the darker side of sample #74, was identified as an acrylic polymer. The black looking material from the darker side of the metal was identified as a phthalate resin product, probably a Dacron™ filler. The presence of an anti-static agent was also detected. The same organic presence was observed on the lighter side of the metal sample although it was much less abundant. Since it is plausible to expect similar results from these materials, they were not examined further. There was a "soot" like substance present on this side that was not found on the previous side. This soot material was extracted, concentrated to dryness and analyzed. The IR data indicates that the major component of the "sooty" material is a zinc oxide which could be the oxidized phase of a zinc based polyvinyl chloride stabilizer.

Figure 18. Glazed looking material from darkest side of sample #74.

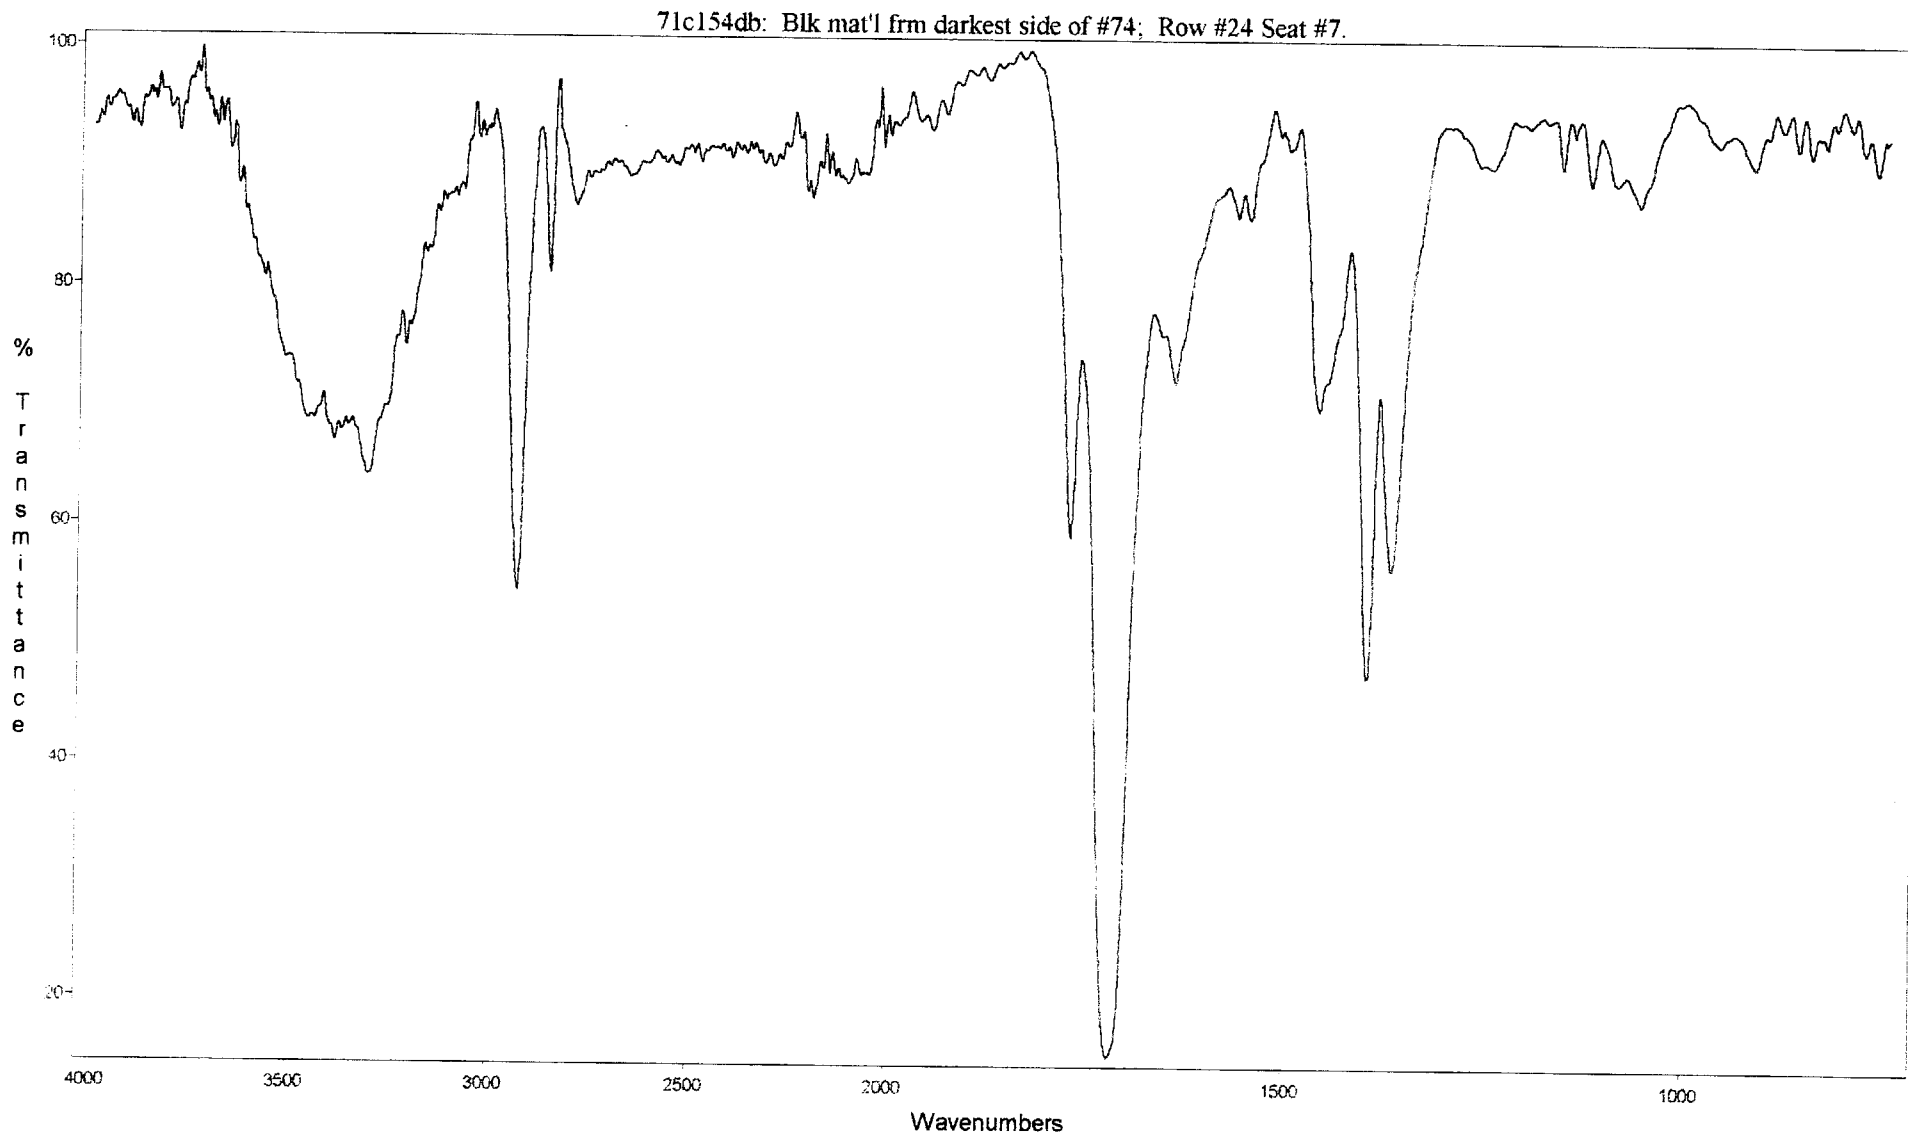
Figure 19. Black material from darkest side of sample #74.
