DOCKET NO. **SA- 516**

**NATIONAL TRANSPORTATION SAFETY BOARD  
WASHINGTON, D.C.**

**ATTACHMENTS TO THE  
SYSTEMS GROUP CHAIRMAN'S FACTUAL  
REPORT OF INVESTIGATION**

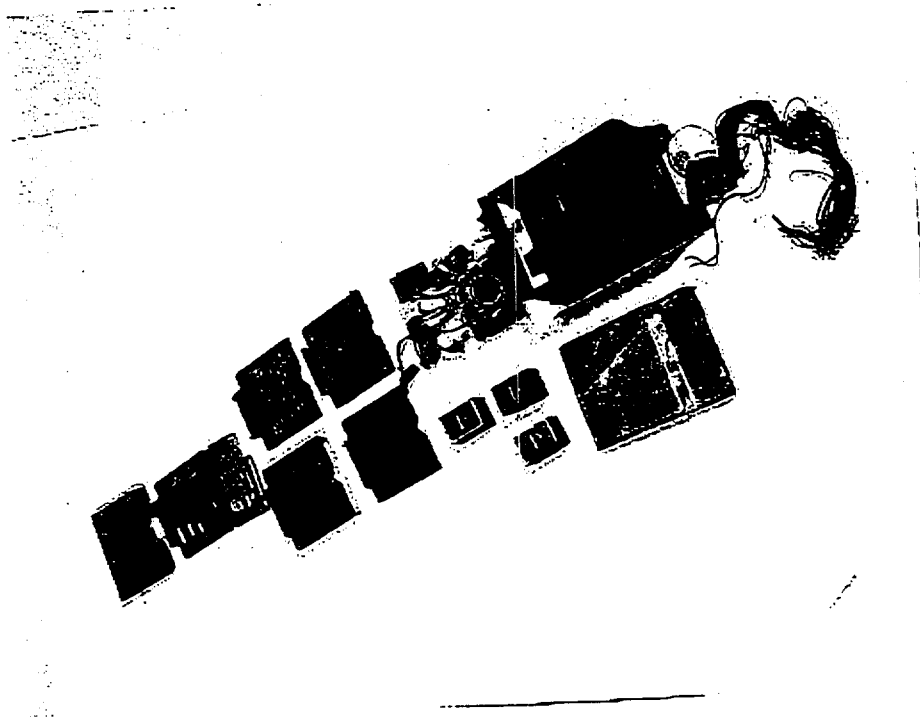
Figure 9. Printed wiring boards removed from an aircraft accident. Note the extensive heat damage to the hardware.

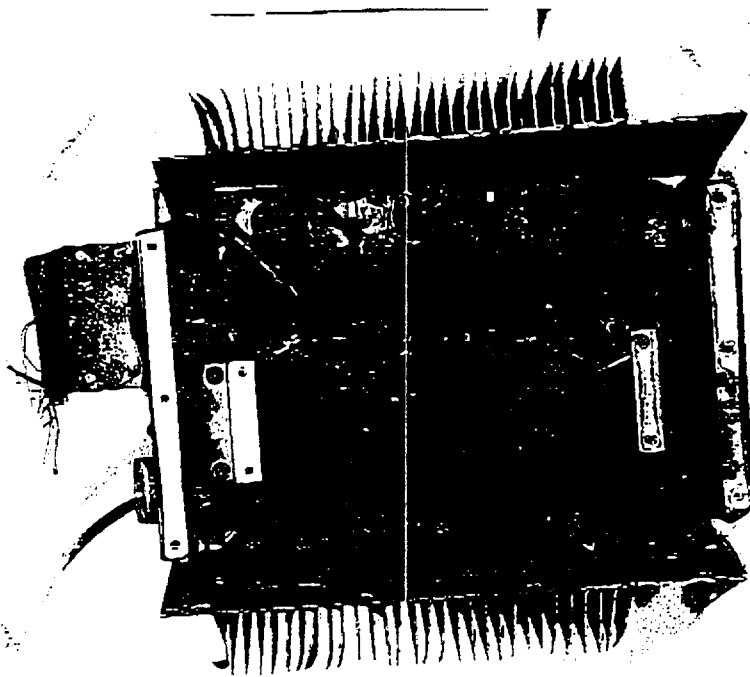
Figure 10. Close-up showing the physical and thermal damage exhibited by electronic hardware involved in an accident.

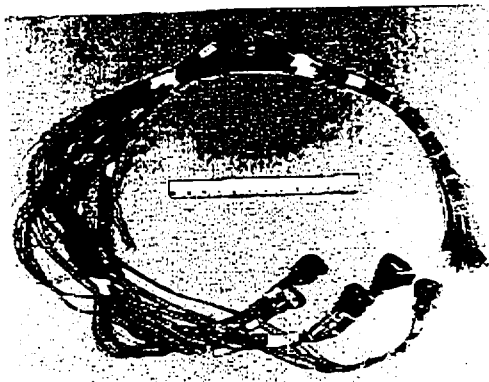
Figure 3. Example of a dry arc propagation failure in MIL-W-81381.

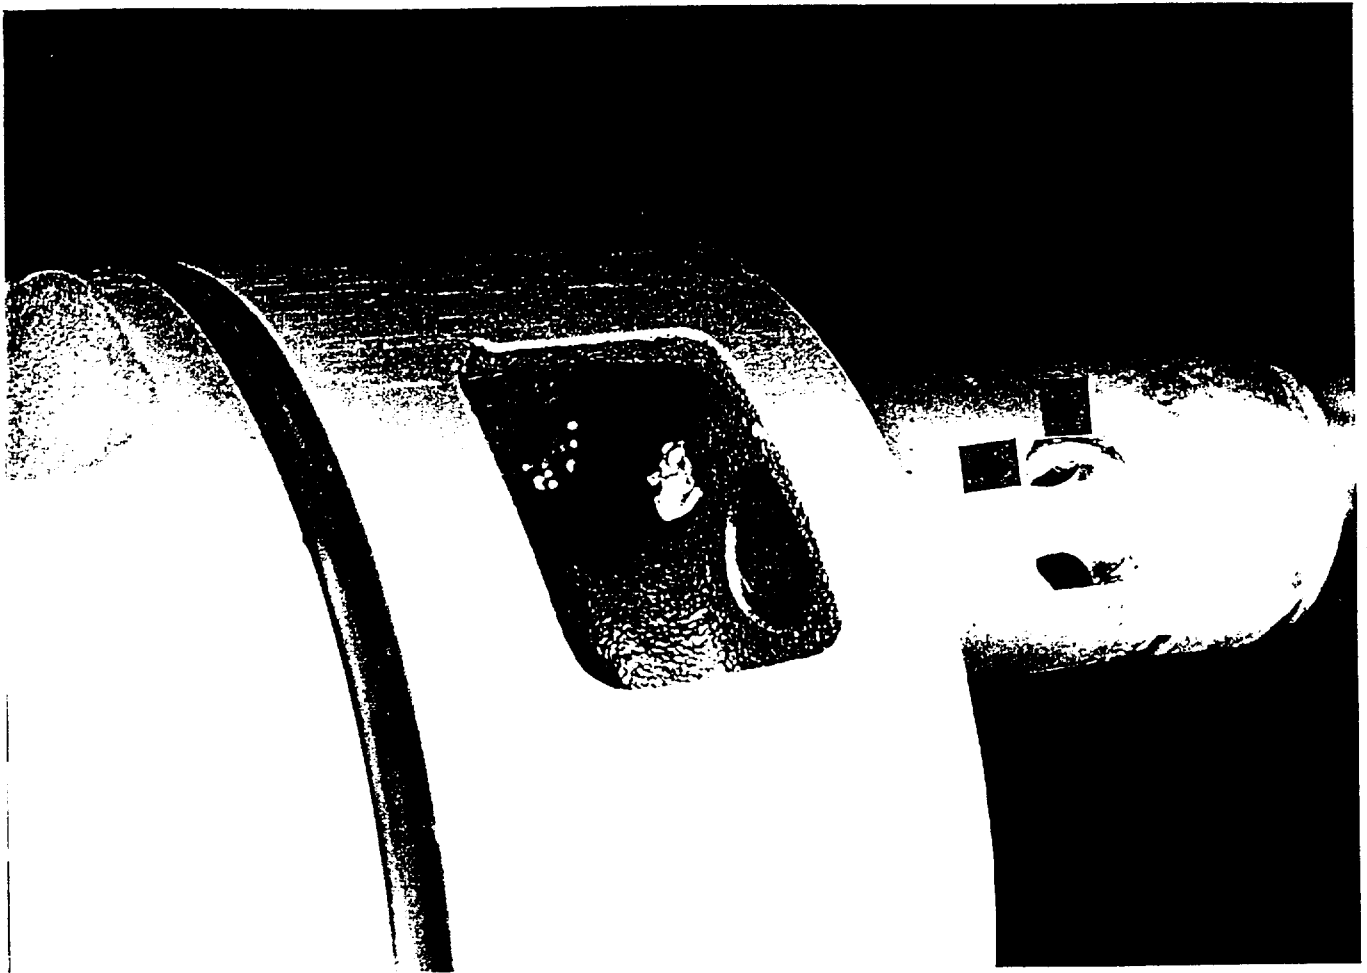
EQUIPMENT QUALITY ANALYSIS  
EQA NUMBER: 1659T  
PIIOTO NUMBER: 9

Reference paragraph 5.3.4 & 5.3.5, A piece of non magnetic metal approximately 0.194" by 0.092" was found in the pump discharge chamber of the pump housing [P/N RR24675-1]. Red arrow indicates a piece of rubber type material approximately 0.297" by 2.16" by 0.048" thick, was also found jammed in the pressure relief valve [P/N RD24684].

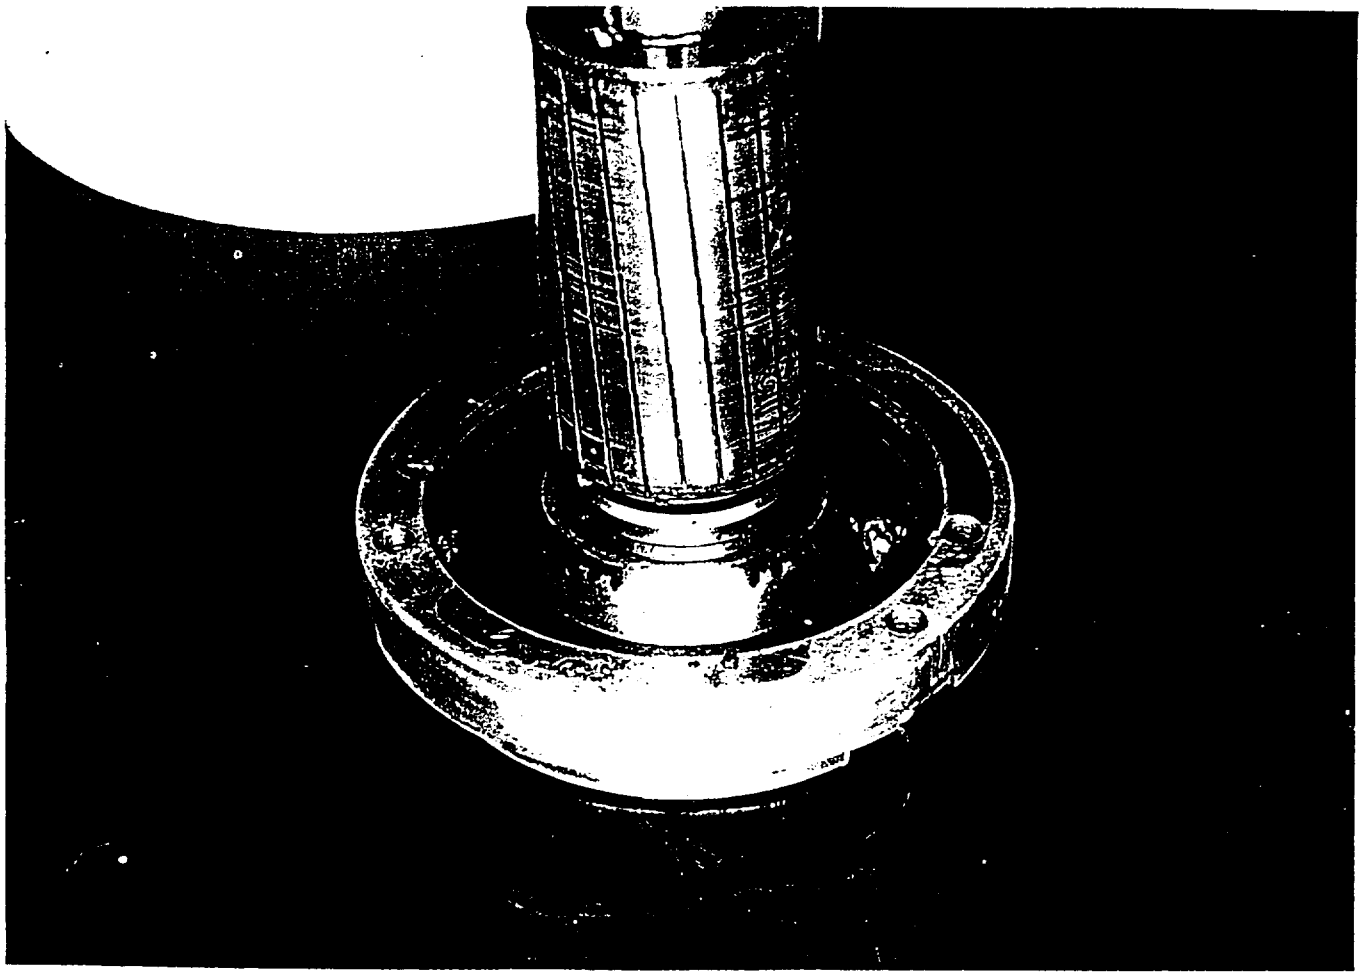
EQUIPMENT QUALITY ANALYSIS  
EQA NUMBER: 1659T  
PIIOTO NUMBER: 24

Reference paragraph 5.8, Examination of the AC motor stator assembly [P/N RG21865] revealed several pieces of red rubber through out the assembly.

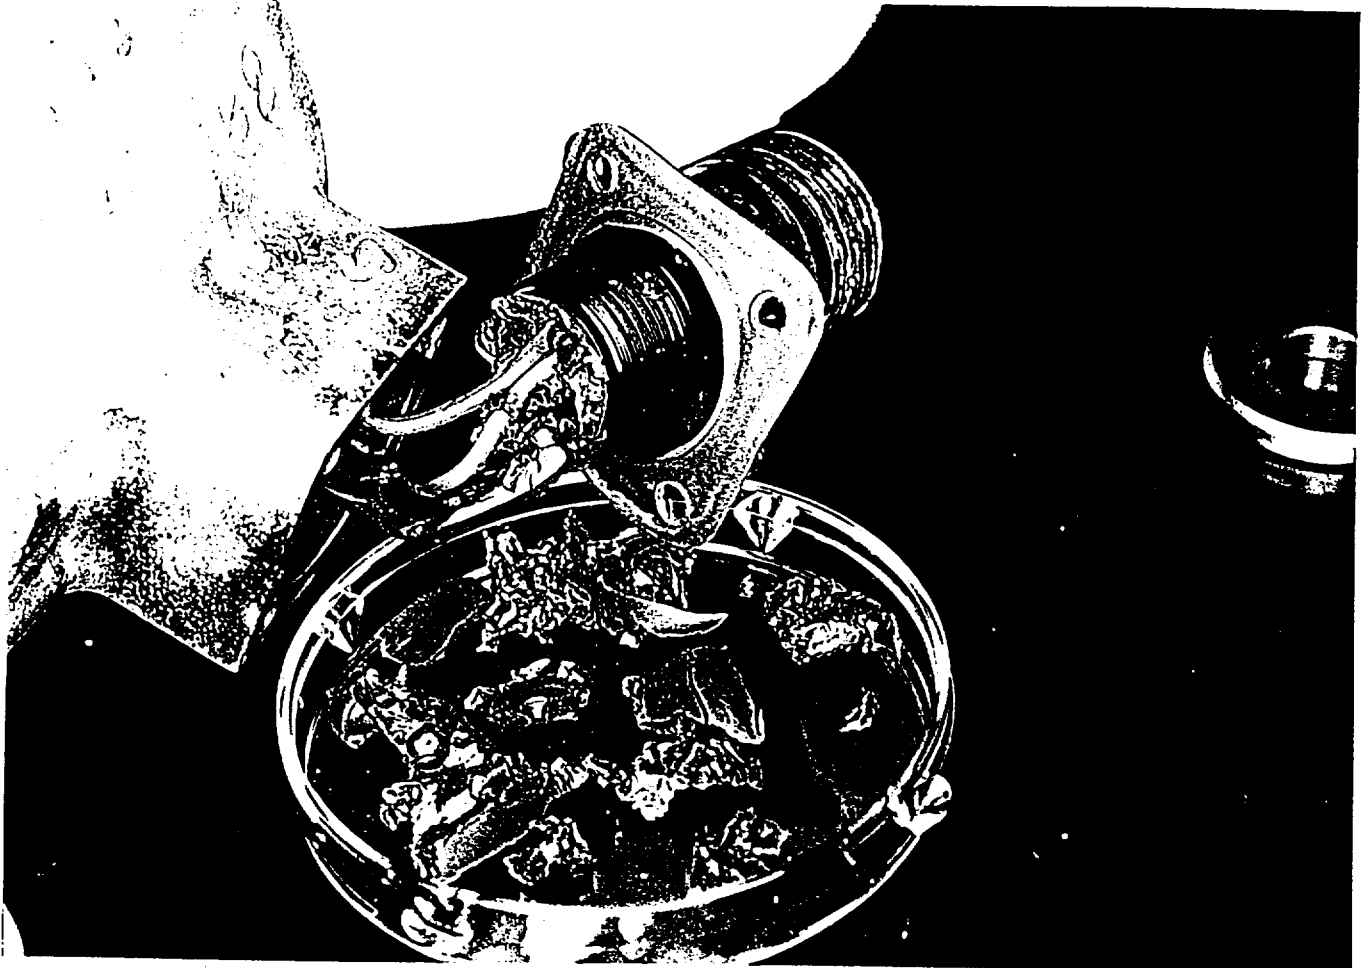
EQUIPMENT QUALITY ANALYSIS  
EQA NUMBER: 1659T  
PIOTO NUMBER: 26

Reference paragraph 5.8.2, The protective sleeving and connector grommet had deteriorated due to contamination and exposure to fuel.

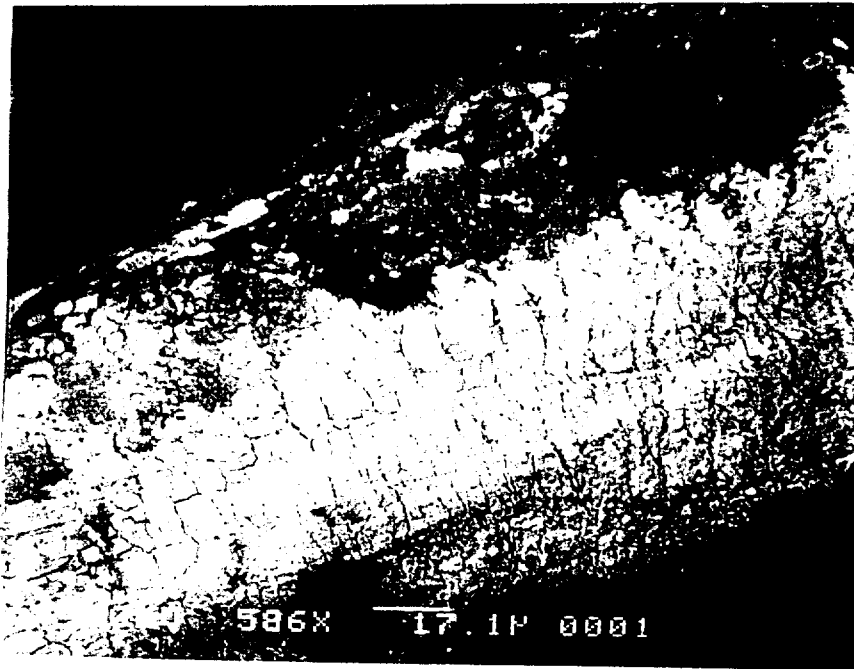
Figure 12. SEM micrograph of the tin coated copper wire in the crimp terminal. Note the cracked tin coating (lighter area) and the exposed copper which contained high levels of sulfur.

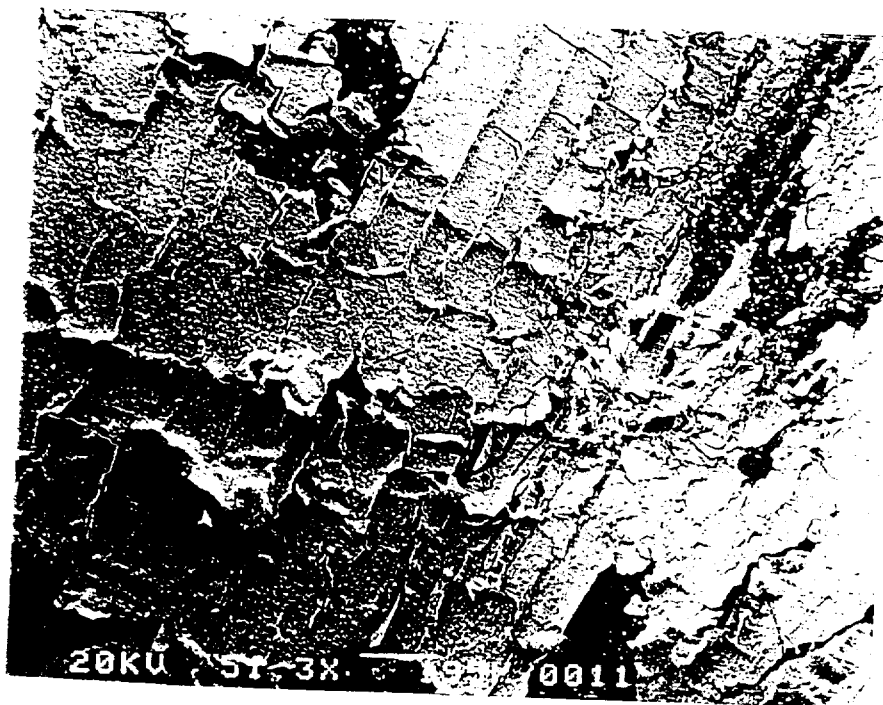
Figure 12. SEM micrograph of residue area in Figure 11. EDXS identified copper, silver, and sulfur. Mag: 51X
