**FQIS Compensator Probe Testing**

Summary Data Report

Investigation of the Effects of Combustion on a  
Fuel Quantity Indicating System Fuel Compensator Probe

January 19, 2000

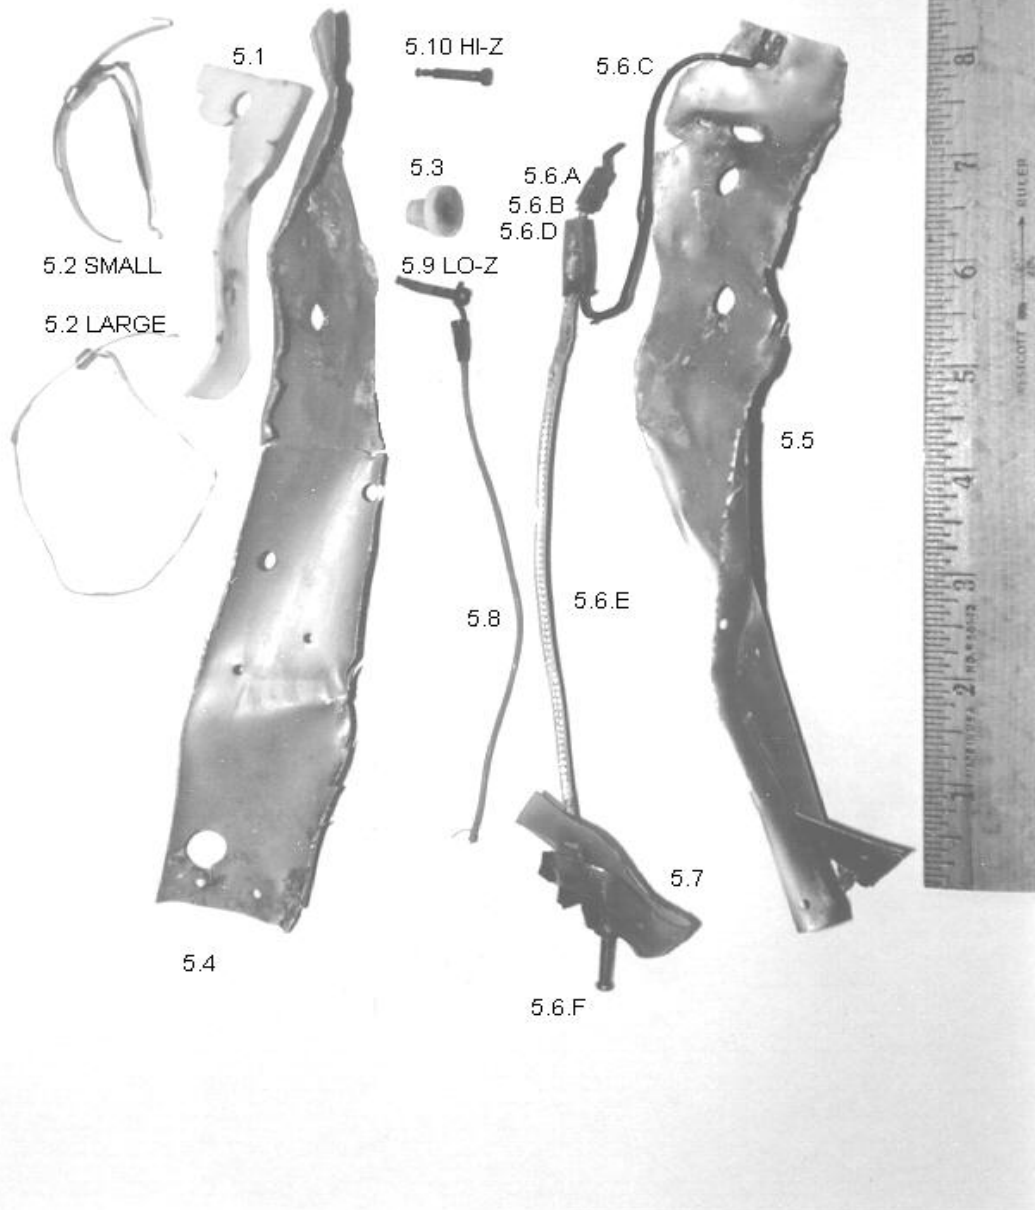
Figure 3. Exploded view of recovered compensator.

Figure 3 shows an exploded view of the compensator recovered from the TWA800 wreckage. Of particular note are the items identified as parts 5.6A, 5.6D, 5.9 LO-Z, and 5.7. These items exhibited thermal damage.
