NATIONAL TRANSPORTATION SAFETY BOARD

**SYSTEMS GROUP CHAIRMAN FACTUAL REPORT ADDENDUM
FOR DEPOSITS ON FUEL TANK ELECTRICAL COMPONENTS**

A. ACCIDENT: DCA96MA070

Location : East Moriches, New York
Date : July 17, 1996
Time : 2031 Eastern Daylight Time
Airplane : Boeing 747-131, N93119
Operated as Trans World Airlines (TWA) Flight 800

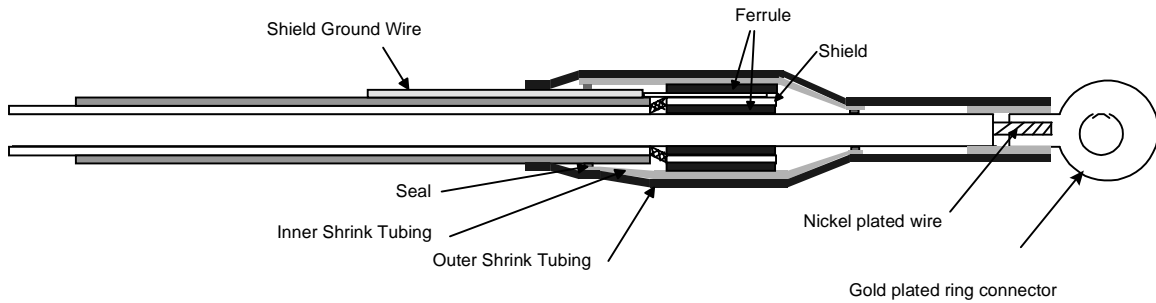
BFGoodrich Illustration of FQIS Ring Connector Attachment to Wire

The BFGoodrich representative stated that the improvement resulted in a large reduction in FQIS accuracy problems and that the inaccuracies had been based on leakage currents through the deposits. The BFGoodrich representative noted that approximately six years had elapsed since the change and that the time was nearly equal to the period that preceded the AFRL report.

1. Use of nickel-plated wire,
2. Use of fold-plated ring connector,
3. Sealant used in shrink tubes,
4. Separate inner and outer layers of shrink tube.
