In accordance with the Board's rules, the Air Line Pilots Association (ALPA) submits the attached comments concerning the accident involving Trans World Airlines Flight 800, which occurred on July 17, 1996, off Long Island, New York.

**SUBMISSION OF THE
AIR LINE PILOTS ASSOCIATION
TO THE
NATIONAL TRANSPORTATION SAFETY BOARD
REGARDING THE ACCIDENT INVOLVING
TRANS WORLD AIRLINES FLIGHT 800
OFF LONG ISLAND, NEW YORK
ON JULY 17, 1996**

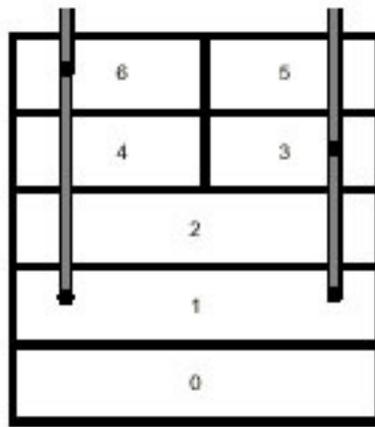
**Map of Tank Bay Designations
from Quarter Scale Test Report**

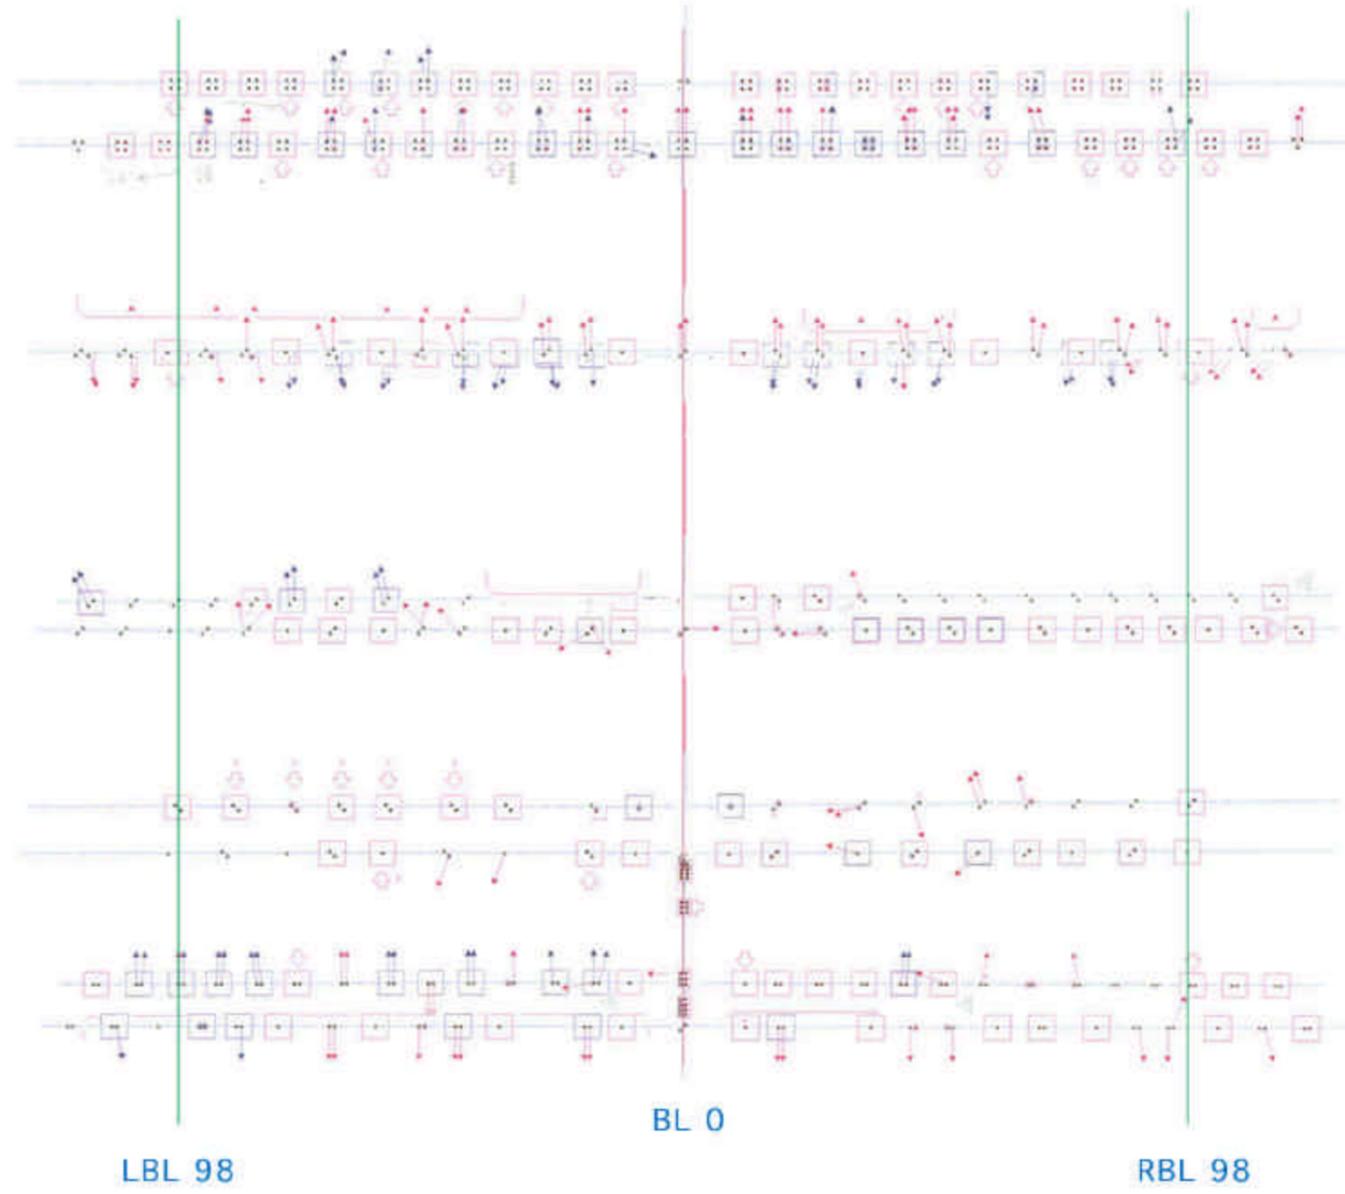
Figure 1

Shear Tie Failure Map

1. Arrows indicate direction of shear tie movement relative to skin
2. Magenta color indicates direction derived from structure remaining on skin
3. Blue color indicates evidence derived from structure remaining on stiffener

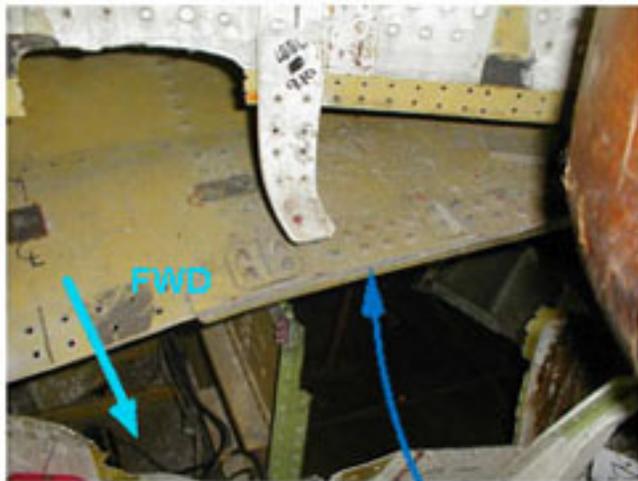
▲
Forward Edge of Front Spar
Lower Chord is Free of Soot
Inboard

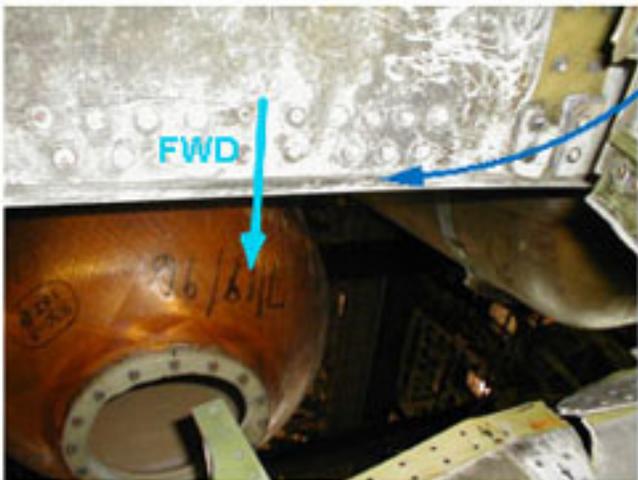
◀ Bottom of Front Spar
Lower Chord Exposed
to ACM Bay is Sooted

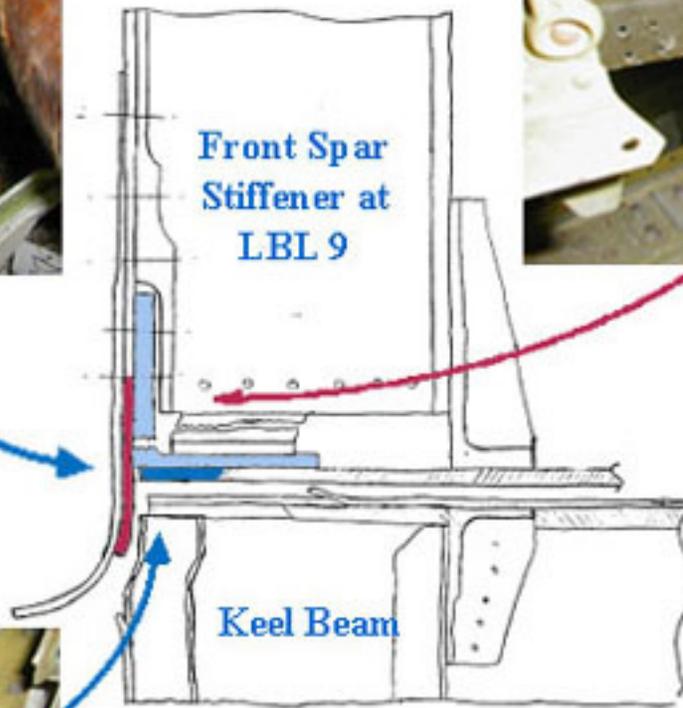
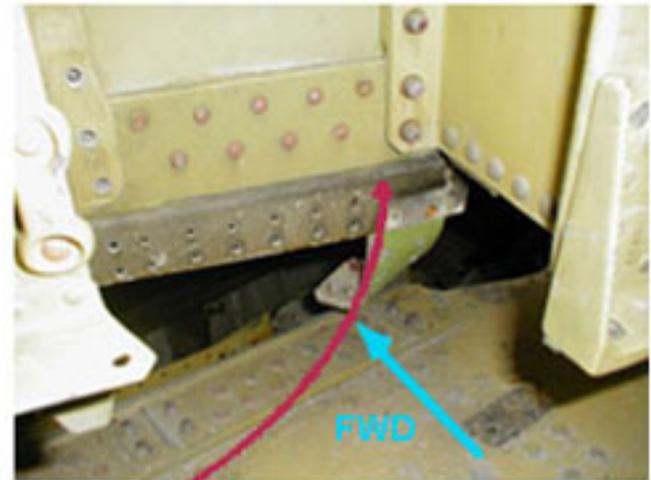
Figure 16

▲
Area of Lap Joint
Normally Hidden by
Front Spar Lower Chord
Exhibits Soot Infiltration

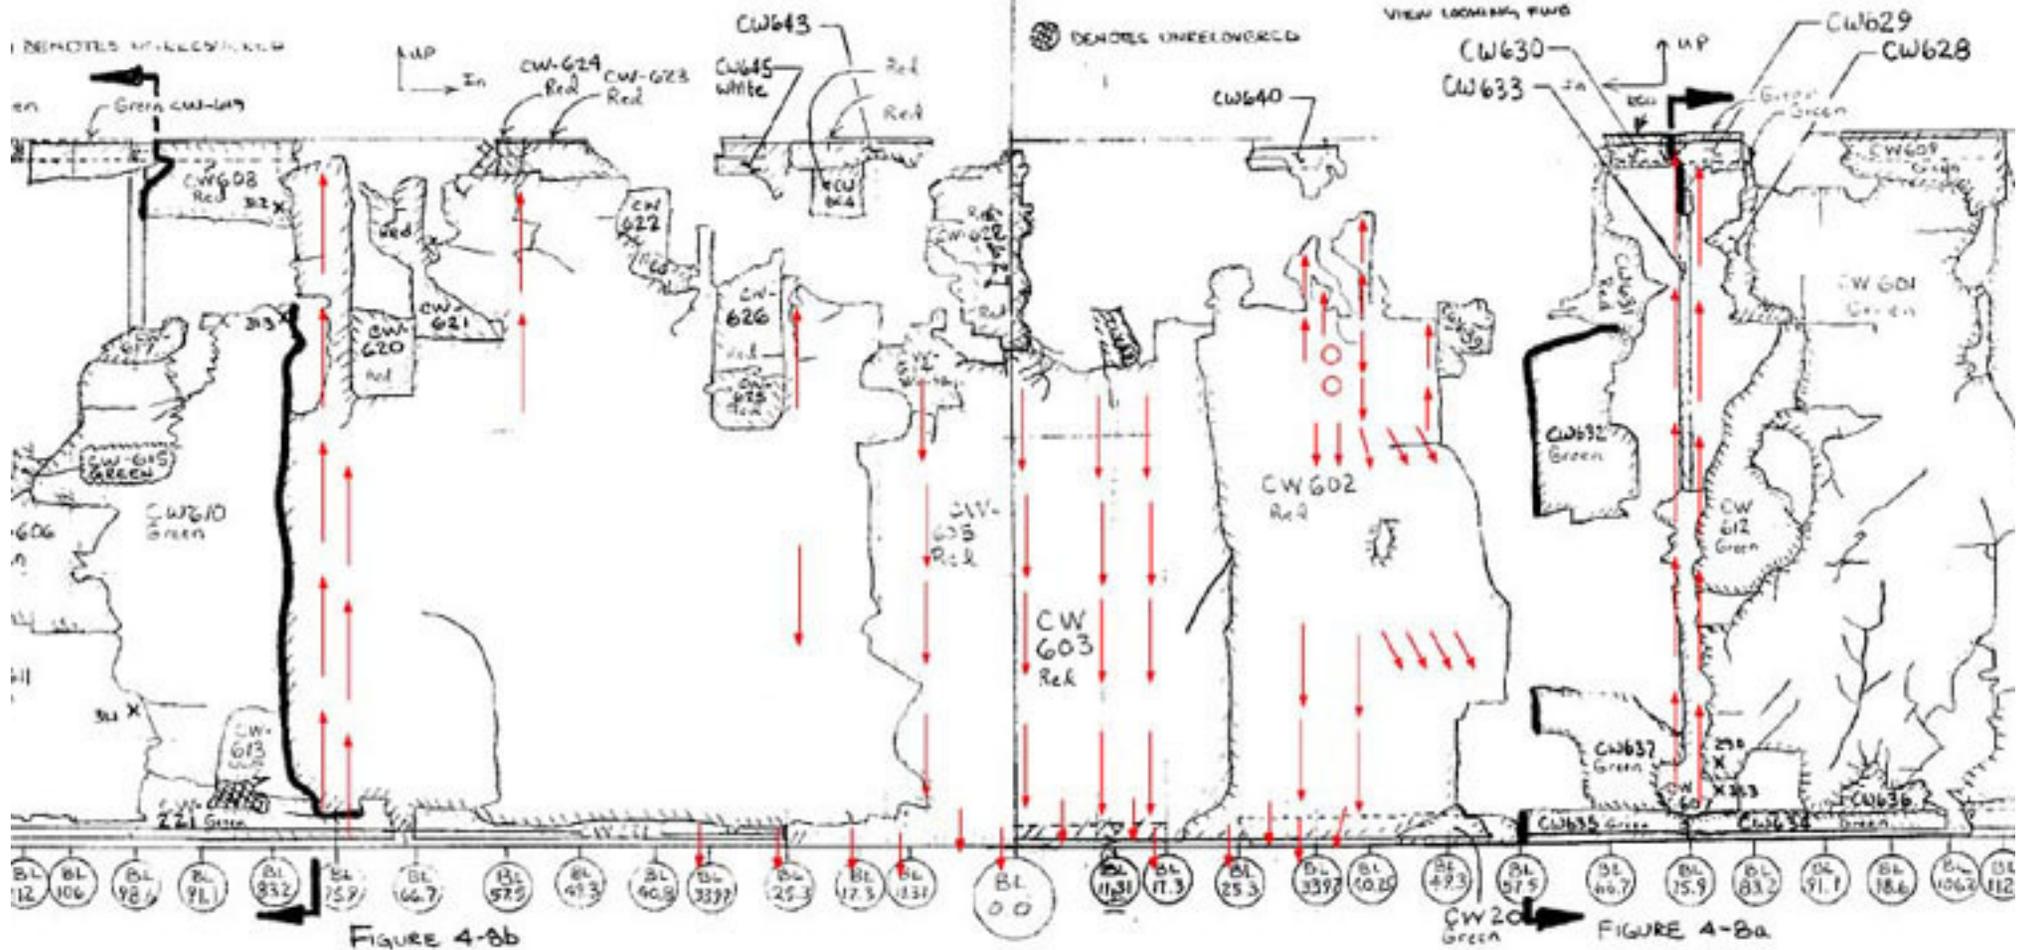
Figure 21

Spanwise Beam 3 Soot Flow Patterns

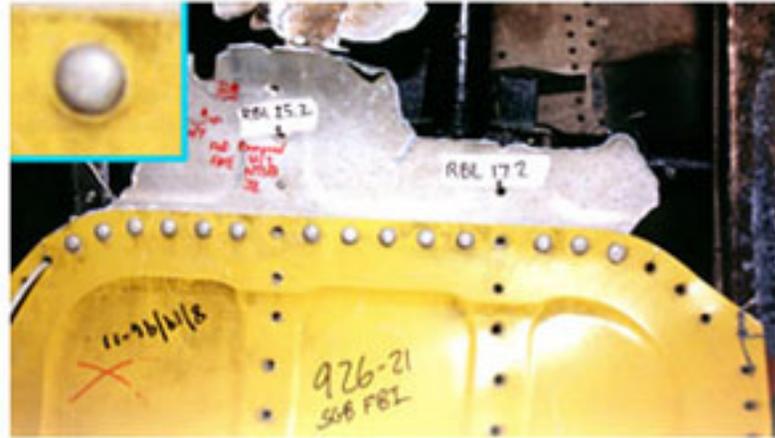
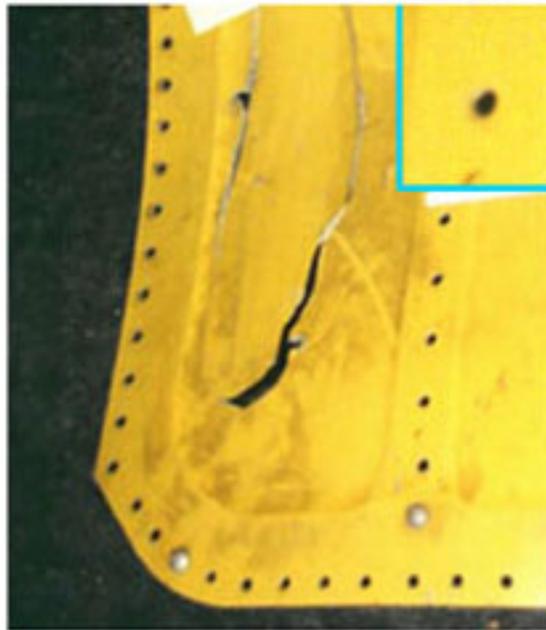
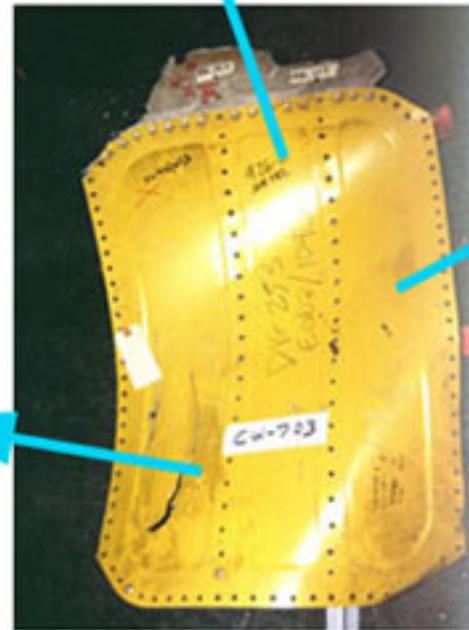
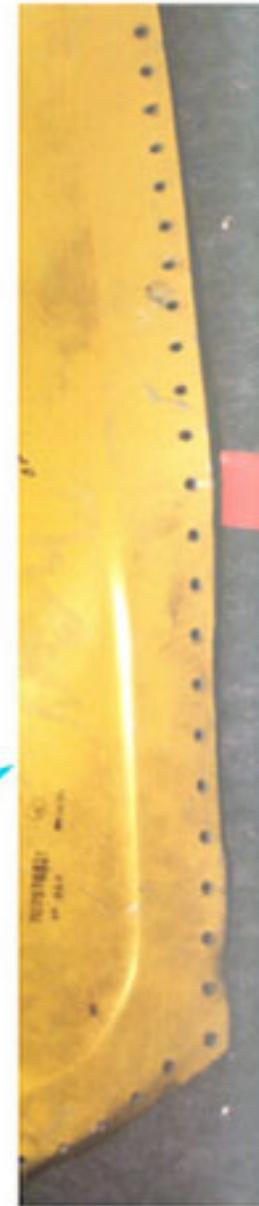
Figure 25

1. Remaining fastener heads exhibit soot accretions with flow generally upward
2. Empty holes do not exhibit soot accretion around fastener head shadow
3. Most empty holes do not exhibit any soot accretion
