EXHIBIT 12 - ANALYSIS OF FLIGHT DATA RECORDER (FDR) 12-SECOND LINE

By Captain Howard T. Mann

TWA Flt. 800, B747-131, Takeoff to End of Data
 Tabular Data No. 1, Created: January 09, 1997, National Transportation Safety Board

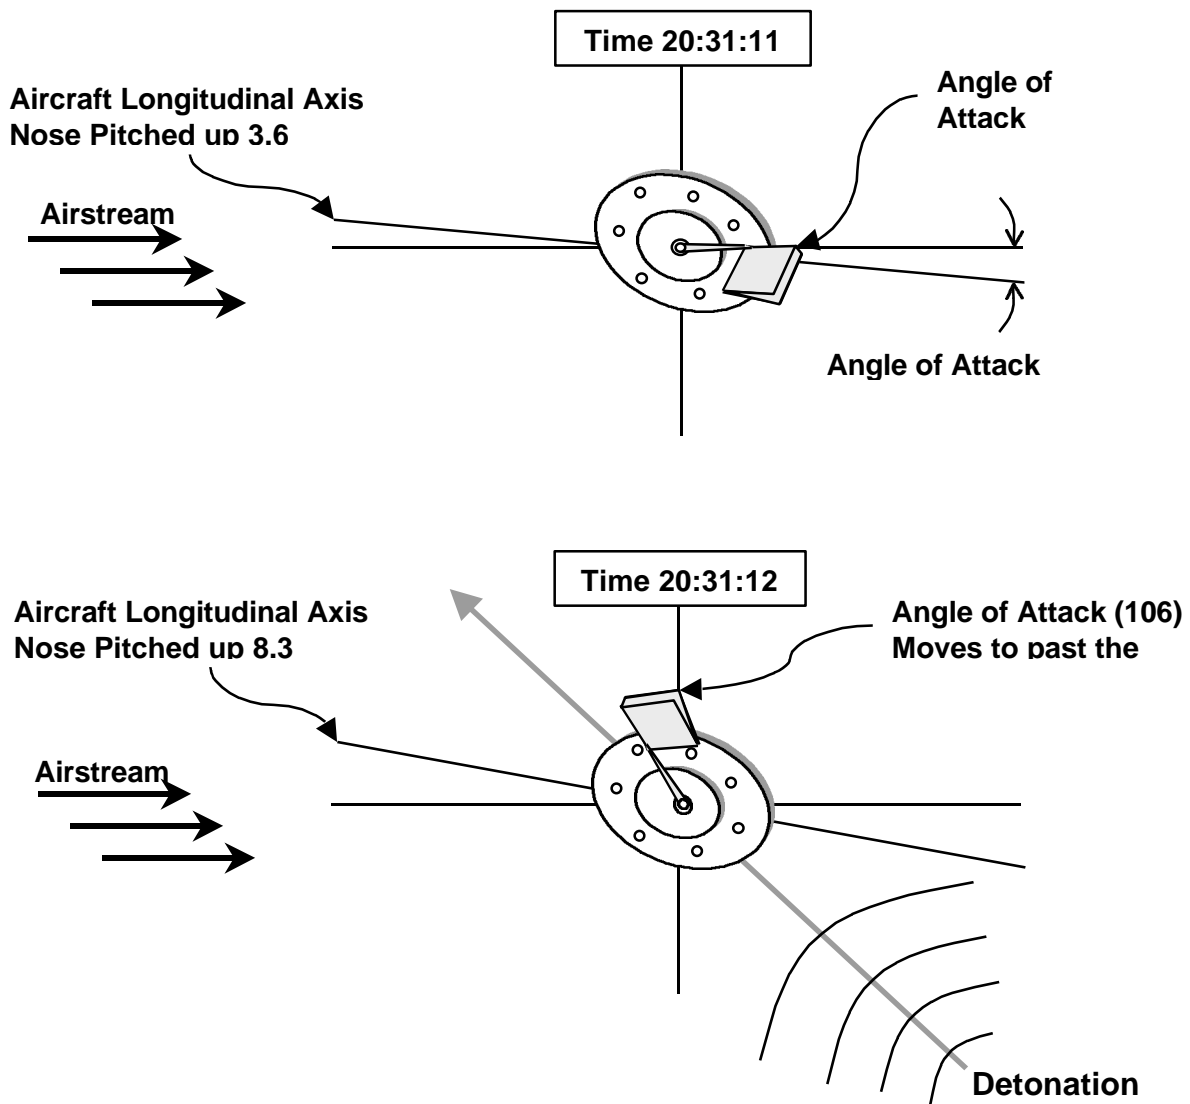
The Angle of Attack represents the angle the airstream is striking the leading edge of the wing. It is sensed by a weather vane device on the left side of the forward fuselage. It is intended to give the pilot advance warning of an imminent stall. Navy jet pilots use Angle of Attack to fly precise landings aboard aircraft carriers. When an aircraft stalls there is buffeting over the wing and a certain amount of shaking. The Stall Warning System augments this warning by shaking the control column. A small electric motor mounted on the forward side of the column incorporates an out of balance flywheel which shakes the control column before the wing actually stalls. Initiation of the warning varies with the amount of wing flaps in use. At Time 20:31:11 the flight data Recorder indicates a normal Angle of Attack of 3 degrees. At the time of the excursions we see on the 20:31:12 second line the FDR indicates an Angle of Attack of 106 degrees, followed by 30 degrees. The 30 degrees is the final Angle of Attack reading from TWA FL800. There is, however, one more Angle of Attack reading on the FDR. That reading of 3 degrees did not come from FL800 but rather from TWA FL803 data that was recorded 25 hours earlier and not yet erased.
