EXHIBIT 23 - PHOTOGRAPHS

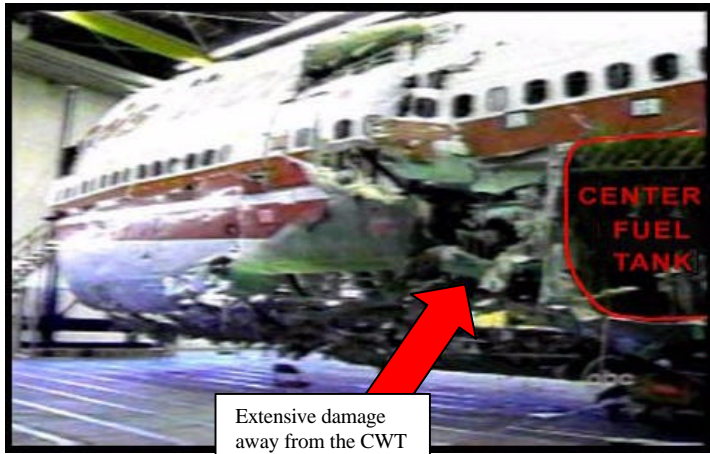
The photograph to the left shows the left side of the aircraft. Notice the high velocity damage which is low on the left side of the fuselage. The corresponds exactly with other calculations of the location of the first warhead blast. There is significant fragmentation at this location with very little skin damage in the surrounding area.

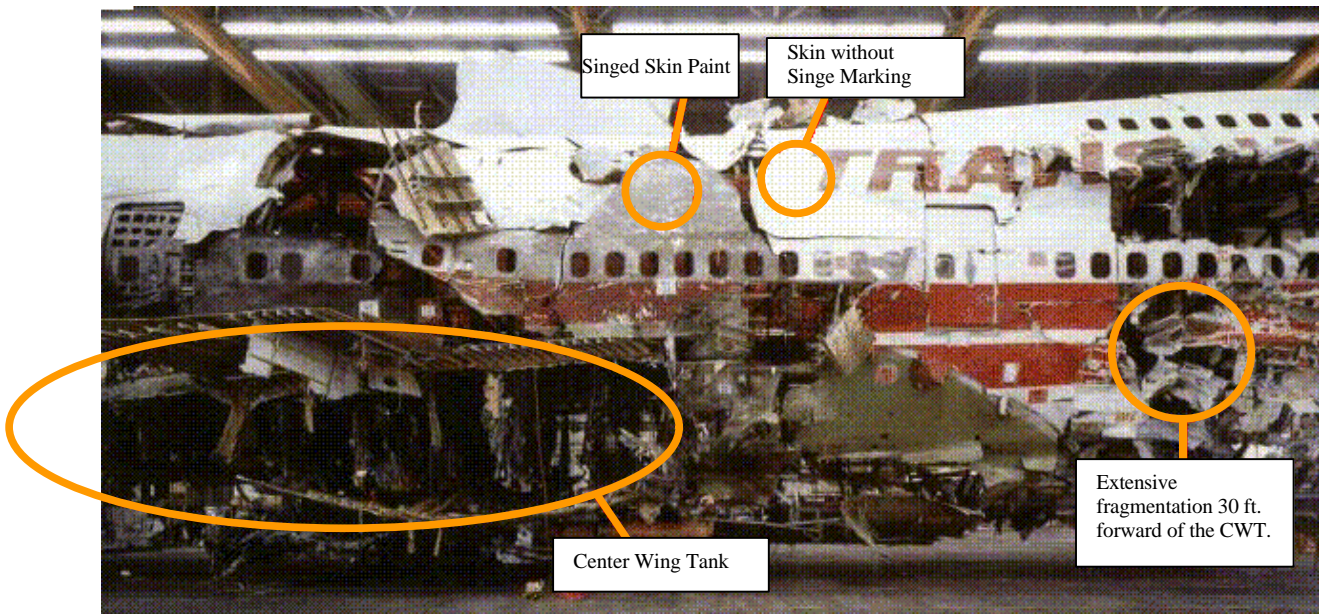
The photograph below shows the right side of the aircraft where the blast damage is

much greater and farther away from the Center Wing Tank. The metal is petaled outward as if a high velocity fragment transited the aircraft from left to right.

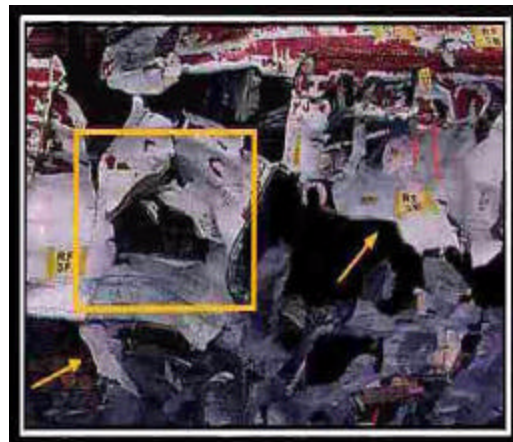
The close up at the right shows the extreme fragmentation on the right side. Notice the metal is petaled outward.

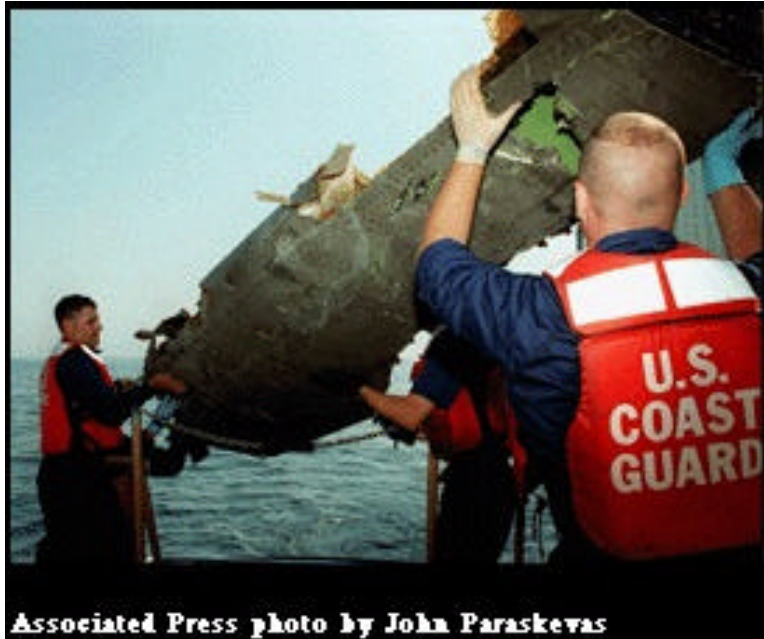
The picture at the left shows the recovery of a part, possibly a wing section, which has a number of holes which appear to have penetrated from the outside in.

The damage to this aircraft part does not appear to be consistent with a low velocity, 60-psi, explosion of the center wing tank or of impact damage from the part hitting the surface of the water. It is indicative of the type of damage that would be expected from a high velocity, anti-aircraft warhead bursting in proximity to the aircraft.

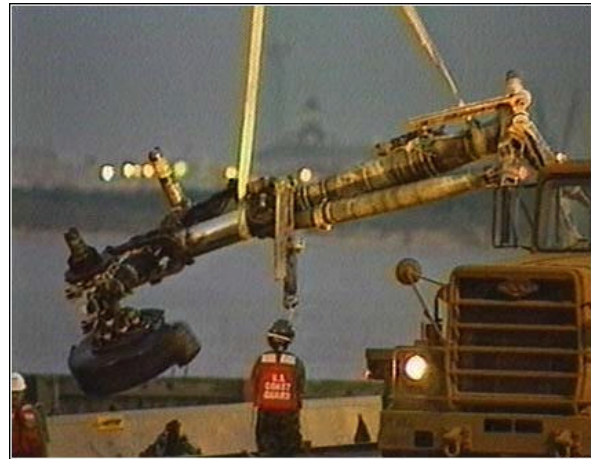
The photograph at the right appears to be a wing landing gear. We know from the debris field that the nose gear doors came off very early and landed in the earliest part of the debris field. A “part of tire” was one of the western most parts of the aircraft, as well as the nose gear doors. Notice the shredded tire in the photograph. Aircraft tires are extremely tough and often survive aircraft crashes intact. A 60 psi center wing tank explosion alone could neither blow off the nose gear doors and separate a nose tire nor do the damage to a wing gear as shown here. On the other hand, this is exactly what one would expect from a proximity-fused warhead exploding below the nose of the aircraft.

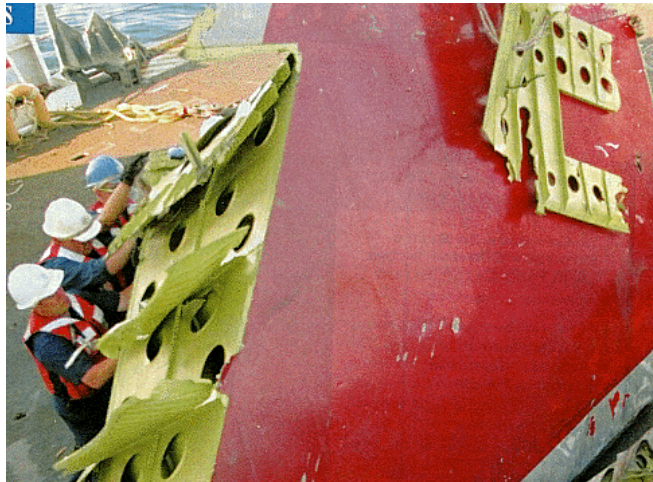
The photograph to the left is part of the tail section vertical stabilizer. Notice the clean, unsooted condition of this large section of the tail. It was located floating by eyewitnesses at least 1 mile from the fuselage impact area. See Captain Adams statement on page 19.

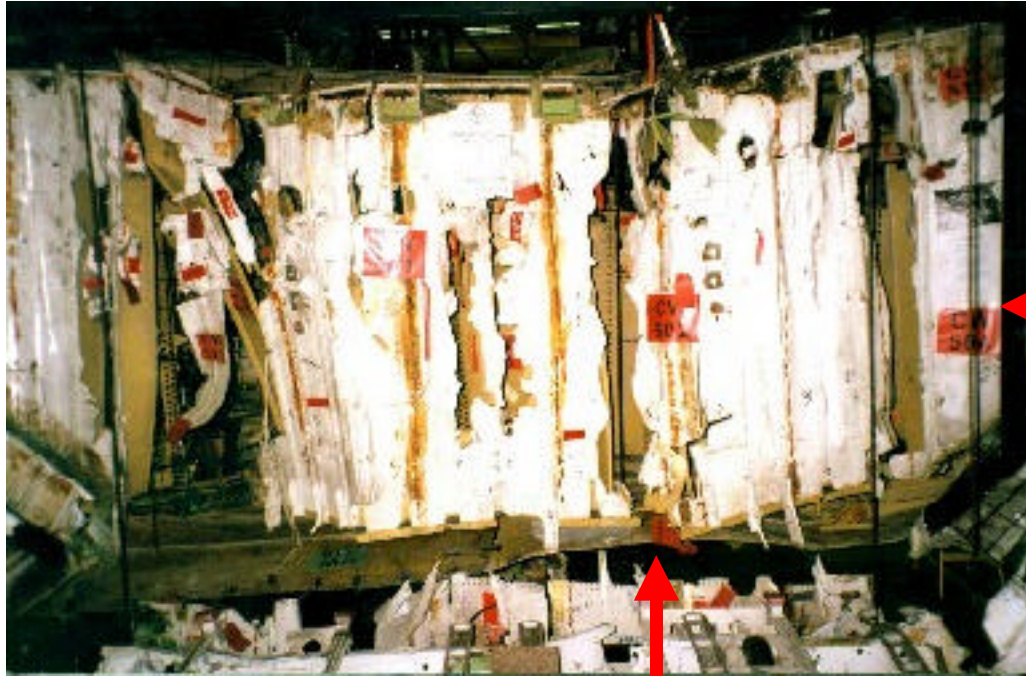
**CW 504.
First part
to leave the
aircraft.**

The picture below shows the front of the Center Wing Tank reconstruction looking back toward the tail of the aircraft from the baggage compartment. CW 504 was the part found in the debris field closest to JFK airport. Therefore, it had to have come off of the aircraft in the initial explosion.

**Left Side of the
aircraft looking
toward the tail.**

**Floor beam is buckled
upward on the lower left
side of the aircraft.**

Notice the damage to the structural Aluminum frame of the Center Wing Tank. The floor beam is buckled upward from the outside of the fuselage. The beam is obviously bowed upward and significantly dented in from the outside. This is completely consistent with the explosion of an airbursting anti-aircraft warhead, below and to the left of the aircraft's nose, just in front of the left wing.
