EXHIBIT 7 - WING SKIN FRAGMENTATION

By William S. Donaldson Cdr. USN Ret.

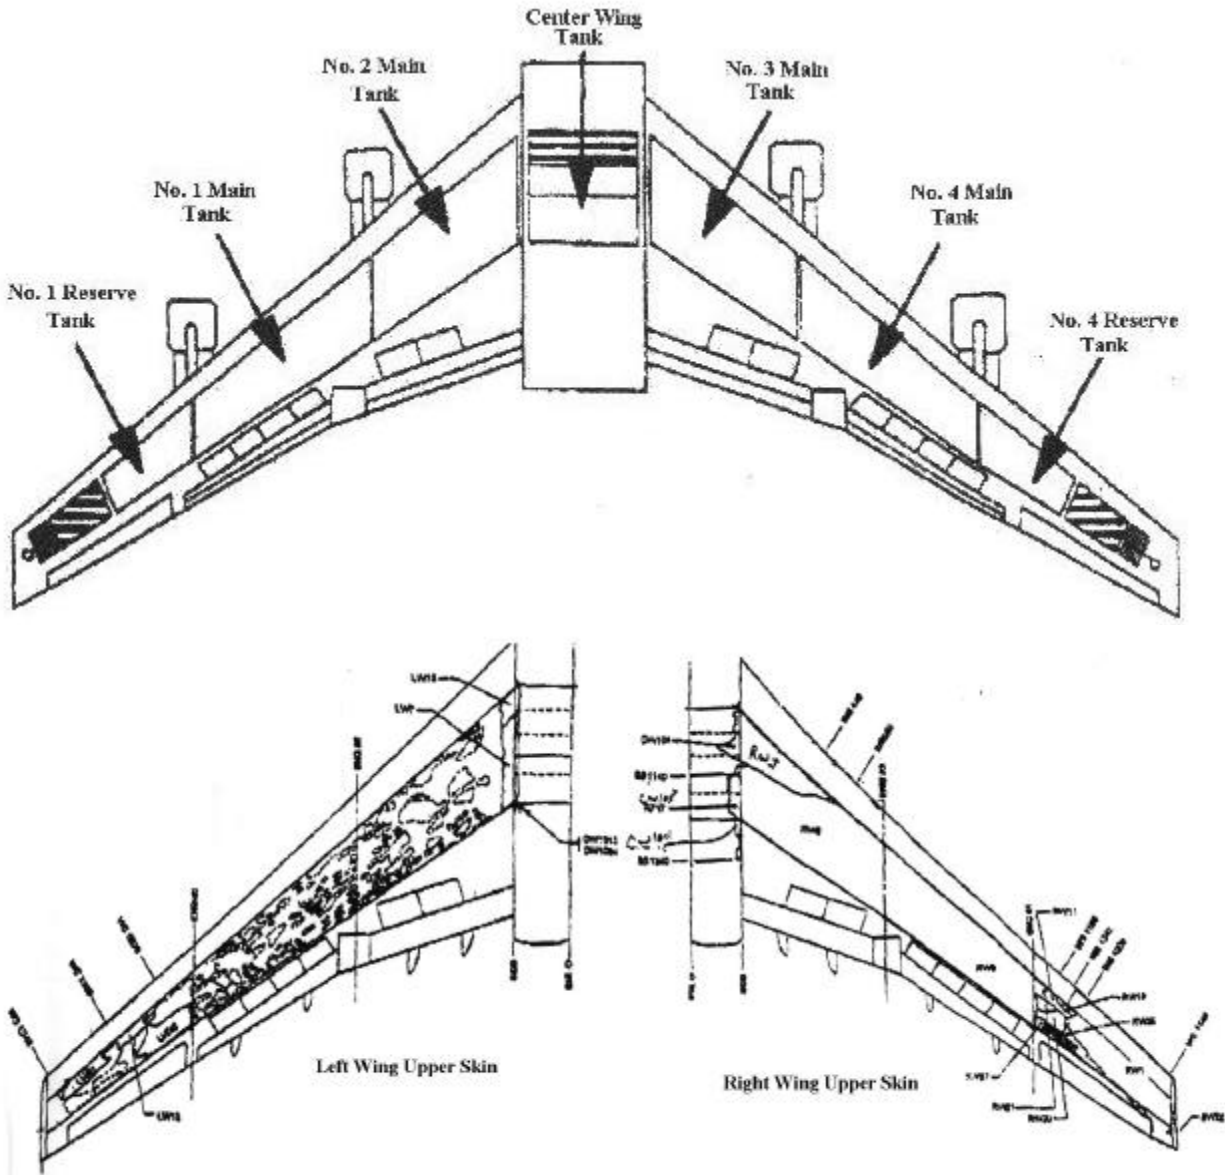
The first diagram shows a normal 747 wing with the location of the wing tanks and the second diagram shows the fragmentation of the upper skin of the left wing. This diagram was produced by analysts at the China Lake Naval Weapons Center. Only hydraulic RAM forces could produce this type of damage pattern.

1. Note the comparison of right and left upper wing skin damage. The bottom skins of both wings do not show this pattern.
2. Note the right wing is far less damaged despite a harder impact with the ocean. It was attached to the heavy fuselage at impact; the left wing was not.

3. The outer third of each wing separated early in the break-up sequence from high G overload.
4. Note extensive damage to left upper wing skin was confined to areas immediately over full or nearly full wing tanks. This implies the damage was a result of hydraulic RAM forces conveyed by fuel immediately under the skin.

5. Note the center section of the left wing sustained the most extensive damage, immediately over the number one main tank. This implies the hydraulic RAM pressure in number one tank was greater than in the number one reserve tank to the left, or the number two main to the right, next to the CWT.

6. This pattern further implies a CWT explosion was not the cause of wing skin damage because of less pressure in the adjacent #2 main.
7. This pattern also implies centrifugal forces were not at work after total wing separation because the outer panel was already damaged and separated with the same pattern prior to the total left wing detachment.

8. The most likely scenario that would explain this pattern would be a high energy blow delivered to a large area of the bottom wing skin centered under the number one main tank. In order to preclude damage to the bottom skin, the blow would have to be both powerful and of very short duration. A high explosive shock wave would deliver such a blow. Depending on the angle of impact, the overpressure would last only a few milliseconds, and would hydraulically load the tank fuel through the bottom skin. Because the fuel is a non compressible liquid, it would simultaneously resist the inward deformation of the bottom skin and deliver the totality of the blow to the bottom side of the left wing upper skin, fracturing it.

9. Different aluminum alloys are used for top and bottom wing skin, specifically tailored to normal, in-flight loading. Wing bottom skin in-flight is under tension (wing tips are trying to bend-up) and the top skin is under compression (tips pushing together). Because of this, the top skin is more ductile to handle compression and the bottom skin more brittle (to handle tension). The fact the more ductile tip skin shattered and the brittle bottom skin didn't further points to a powerful outside force. A simple interior overpressure would have had the opposite effect.

10. Note the left wing smaller fracture pieces (highest energy) are located over the aft portions of the #1main and #2 main tanks. This could be because tank thickness is diminished at that area but it also could be from shock wave impact angle. If the shock wave struck from forward as well as below the wing, the overpressure would first begin to deform the forward lower skin up into the tank until what ever airspace available in the tank was displaced by non-compressible fuel. This would actually form a depression wave in the bottom skin moving from front to back of the tank at the speed of the shock wave. The upper AFT portion of each tank would not only experience the normal overpressure, but would receive additional RAM pressure from the wave effect slamming Aft into a narrower tank.

11. Note, this damage pattern conforms with initiating event overpressure data recorded on the FDR and CVR, tension failure on bottom fuselage skin forward, compression failure of top fuselage skin forward, first loss of cabin integrity forward fuselage, bottom to top, left to right crack propagation of the skin forward fuselage and discovery of small wing skin parts during dredging in the early debris field.

12. It most assuredly does not conform to a low-pressure CWT burn.
