5. Appendixes

Transcript of a Fairchild Model A-100 Cockpit Voice Recorder S/N UNK which was removed from a Trans World Airlines, Inc., Boeing Commercial Aircraft Co. B747-100 N93119, which was involved in an inflight accident on July 17, 1996 approximately 10 miles south of East Moriches, New York.

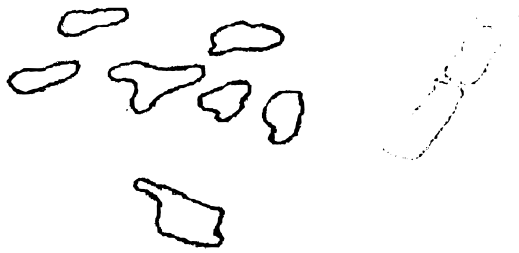
UPPER SKIN - EXTERNAL SURFACE

NOTE: With the exception of the piece noted, the external surface of the upper skin is clean. The control surfaces do show sooting and Arc damage to the composite parts.

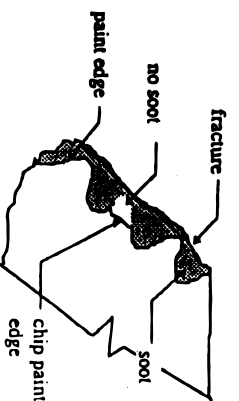
Determination primarily made by examining external paint failures near the fracture edge. Soot deposits remain on underlying paint when the top layer peels near fracture.
