**DOCKET NO. SA-516**

**FIRE AND EXPLOSION GROUPS FACTUAL REPORT**

TWA FLIGHT 800 ACCIDENT INVESTIGATION

**APPENDIX III**  
**TESTS AND ANALYSIS RESULTS**

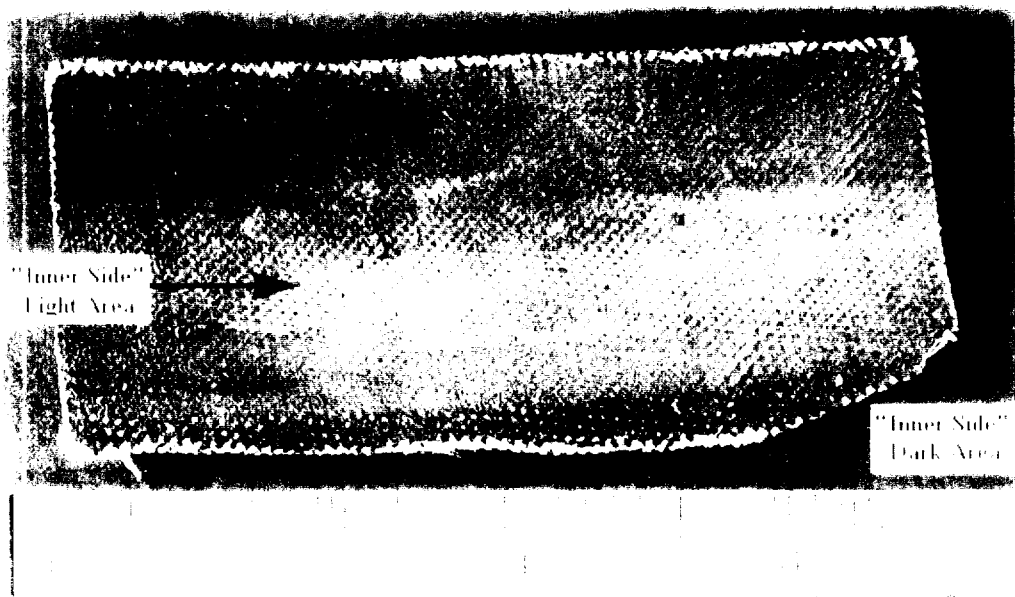
**Figure 5: Overview of "Inner Side"**

- 4.4 An EDS analysis of the dark tinted surface area on the inner side of the sample (Refer to Figure 5) shows high concentrations of chlorine, moderate amounts of oxygen, silicon, carbon and sodium with minor to trace amounts of sulfur, magnesium, aluminum, potassium, calcium, barium, iron and zinc. The EDS chart of these findings is provided in Figure 6.

- 4.5 An EDS analysis of the light tinted surface area on the inner side of the sample ( Refer to Figure 5) shows high concentrations of chlorine, moderate amounts of oxygen, silicon, carbon and sodium with minor to trace amounts of sulfur, magnesium, aluminum, potassium, calcium, barium, iron and zinc. The EDS chart reflecting these measurements is provided in Figure 7.

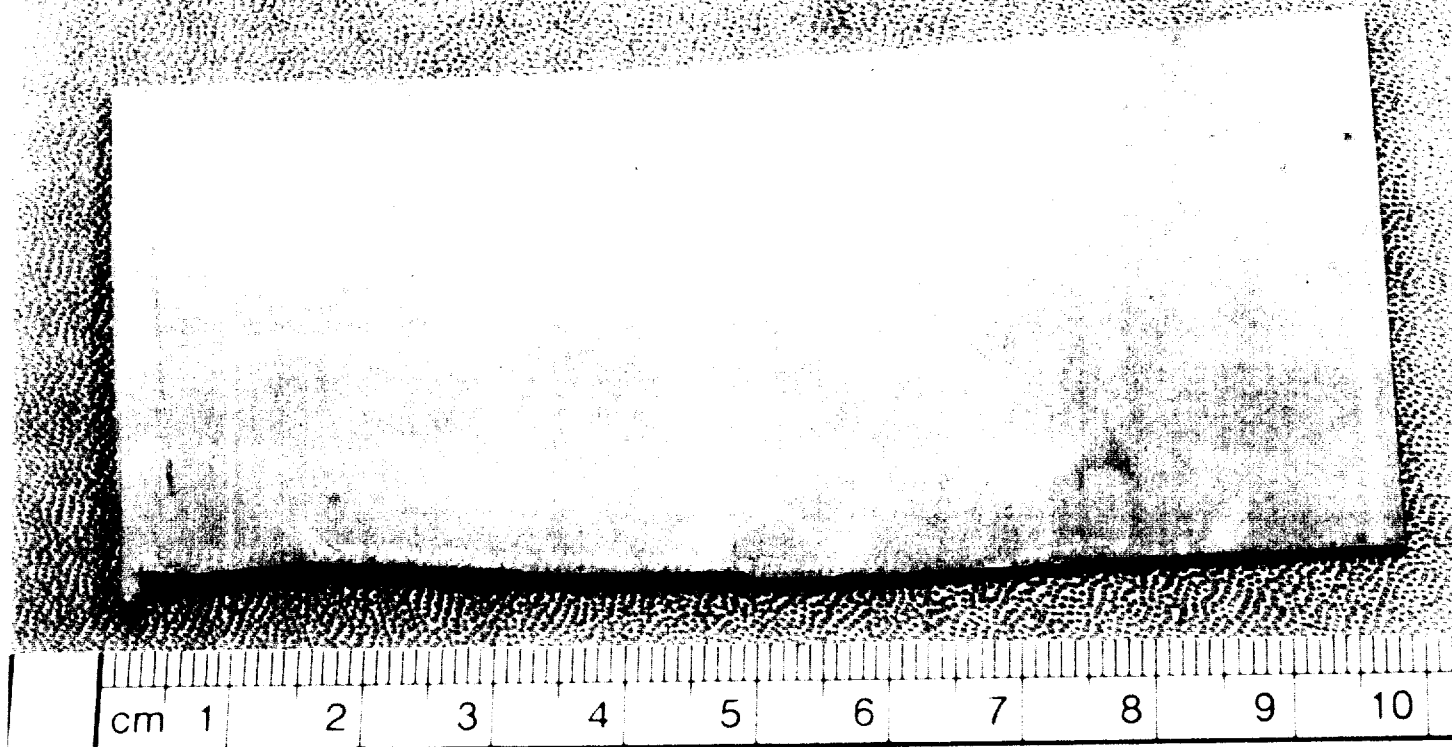
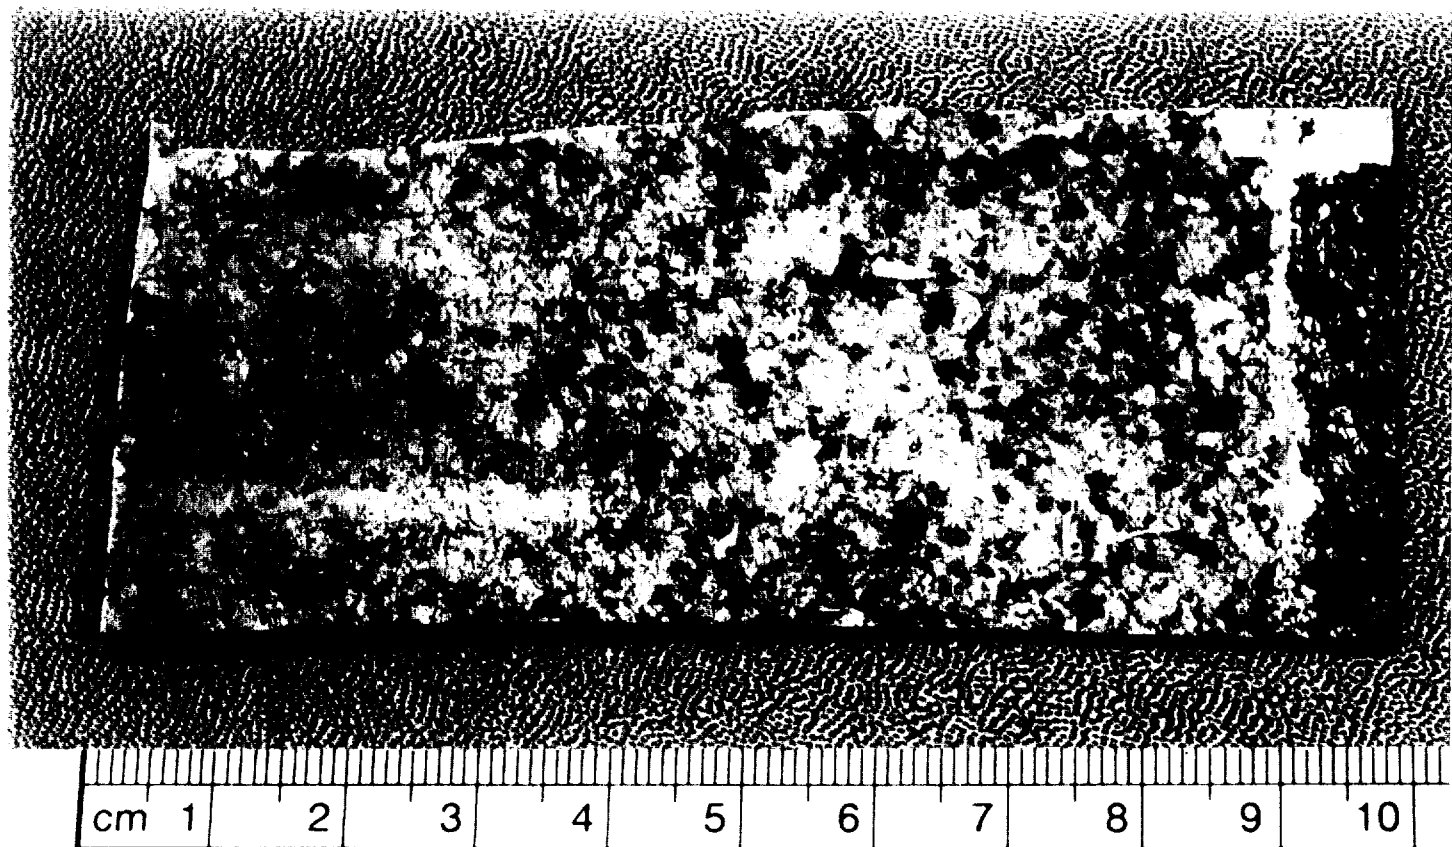
Figure 7. Sample #70, Row #17, Seat #8.

- 3.3 Sample #70, Row 17, Seat 8 (Figure 7) appeared to be a plastic or vinyl material with some of the unknown red material on one side. For the purposes of this discussion, the side which contained none of the suspected adhesive material will be referred to as the clean or non-contaminated side and the side which did contain some of the suspected adhesive material will be referred to as the contaminated side. FTIR spectra was generated for the clean side and for the contaminated side, the spectra of which are provided as Figure 8 and Figure 9 respectively. The spectrum of the reference adhesive was compared to the spectrum of the unknown red material. The spectral comparison is provided in Figure 10 and a spectral overlay in Figure 11.

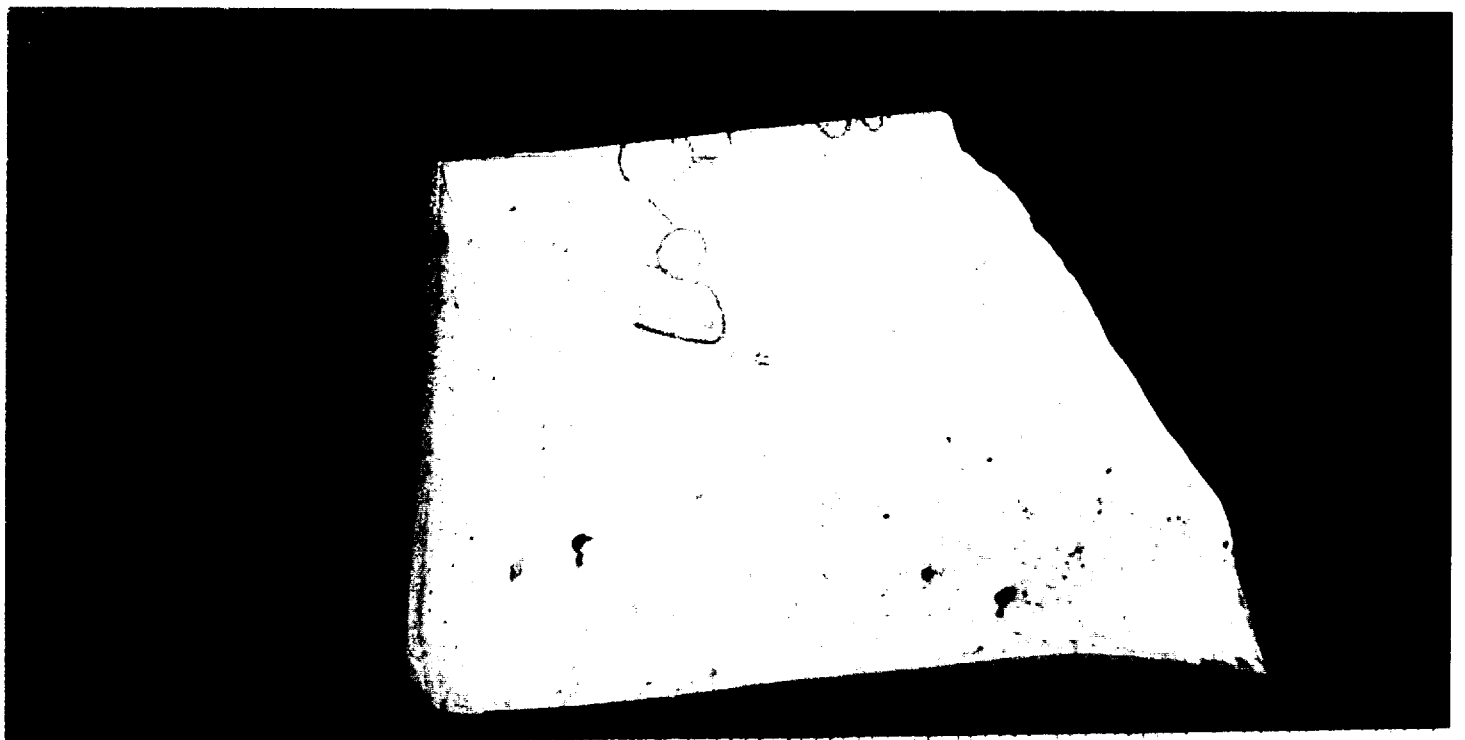
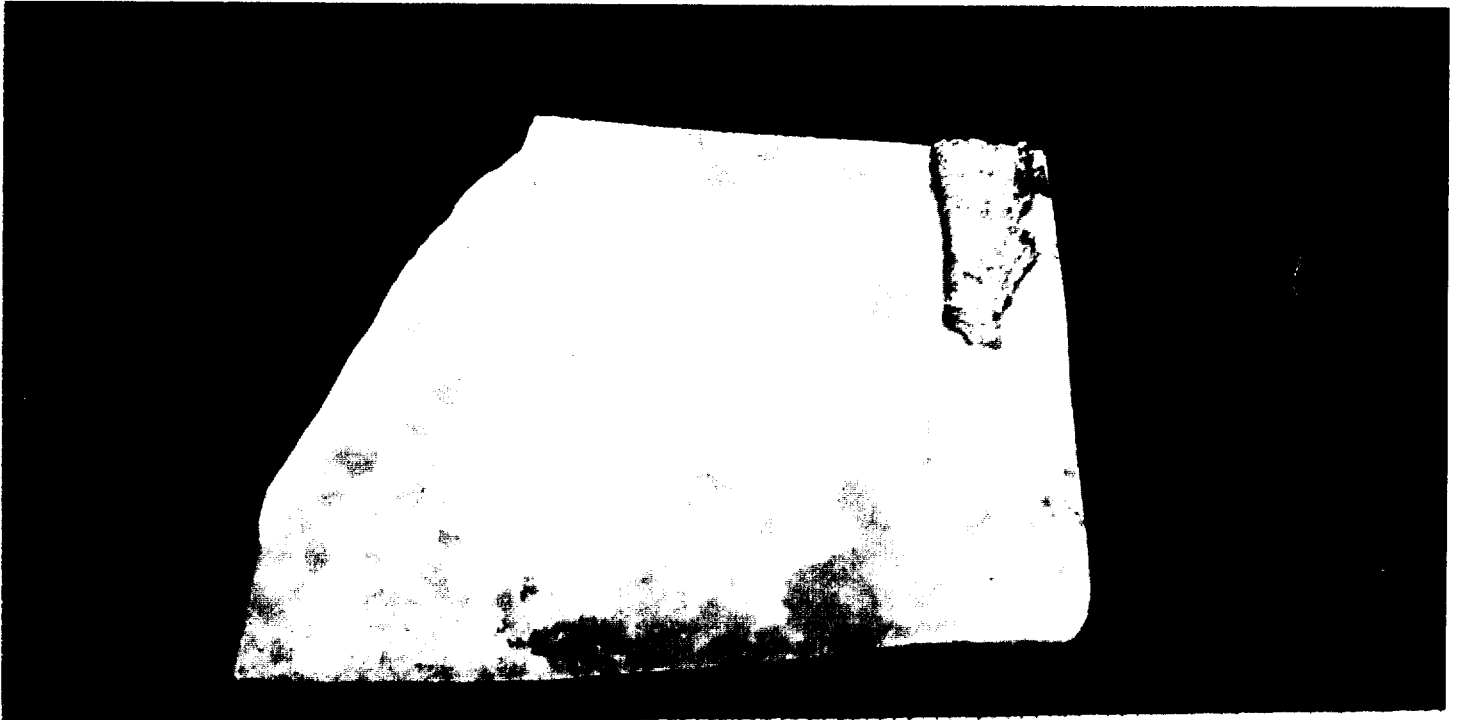
Figure 12. Sample #73, Row #27, Seat #2.

- 3.4 The plastic or vinyl material from sample #73, Row 27, Seat 2 (Figure 12) was contorted much like the deformation which occurs when exposed to heat, whereas the material of sample #70 was smooth and exhibited no such altered conformation. Additionally, the unknown material which was attached to one side of sample #73 was tan or reddish-brown, whereas the contaminated side of sample #70 was red. The spectrum for the clean side of sample #73 is provided in Figure 13 and the spectrum for the contaminated side of the sample is provided in Figure 14. A spectral comparison of the reference adhesive and the red-brown material is provided in Figure 15 and a spectral overlay in Figure 16.

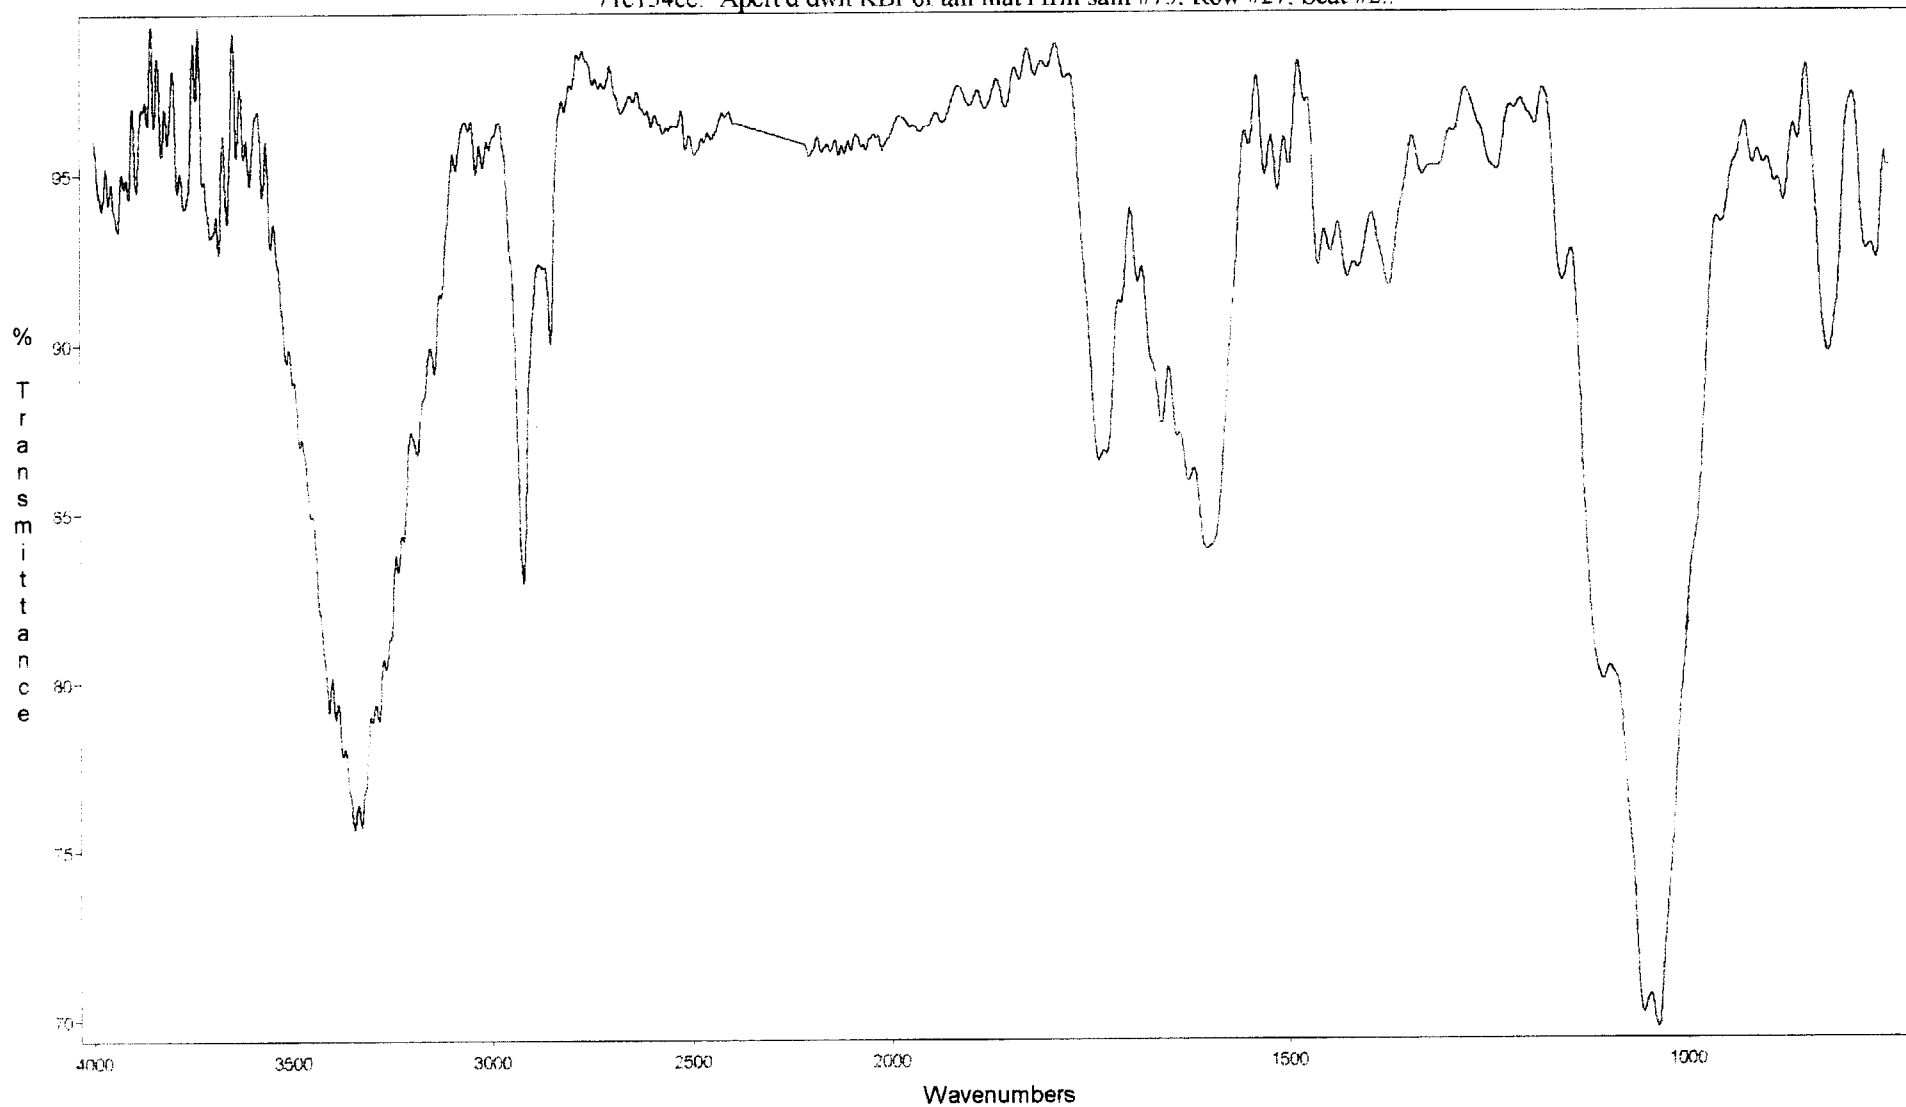
Figure 14. IR spectrum of contaminated side of sample #73, Row #27, Seat #2.

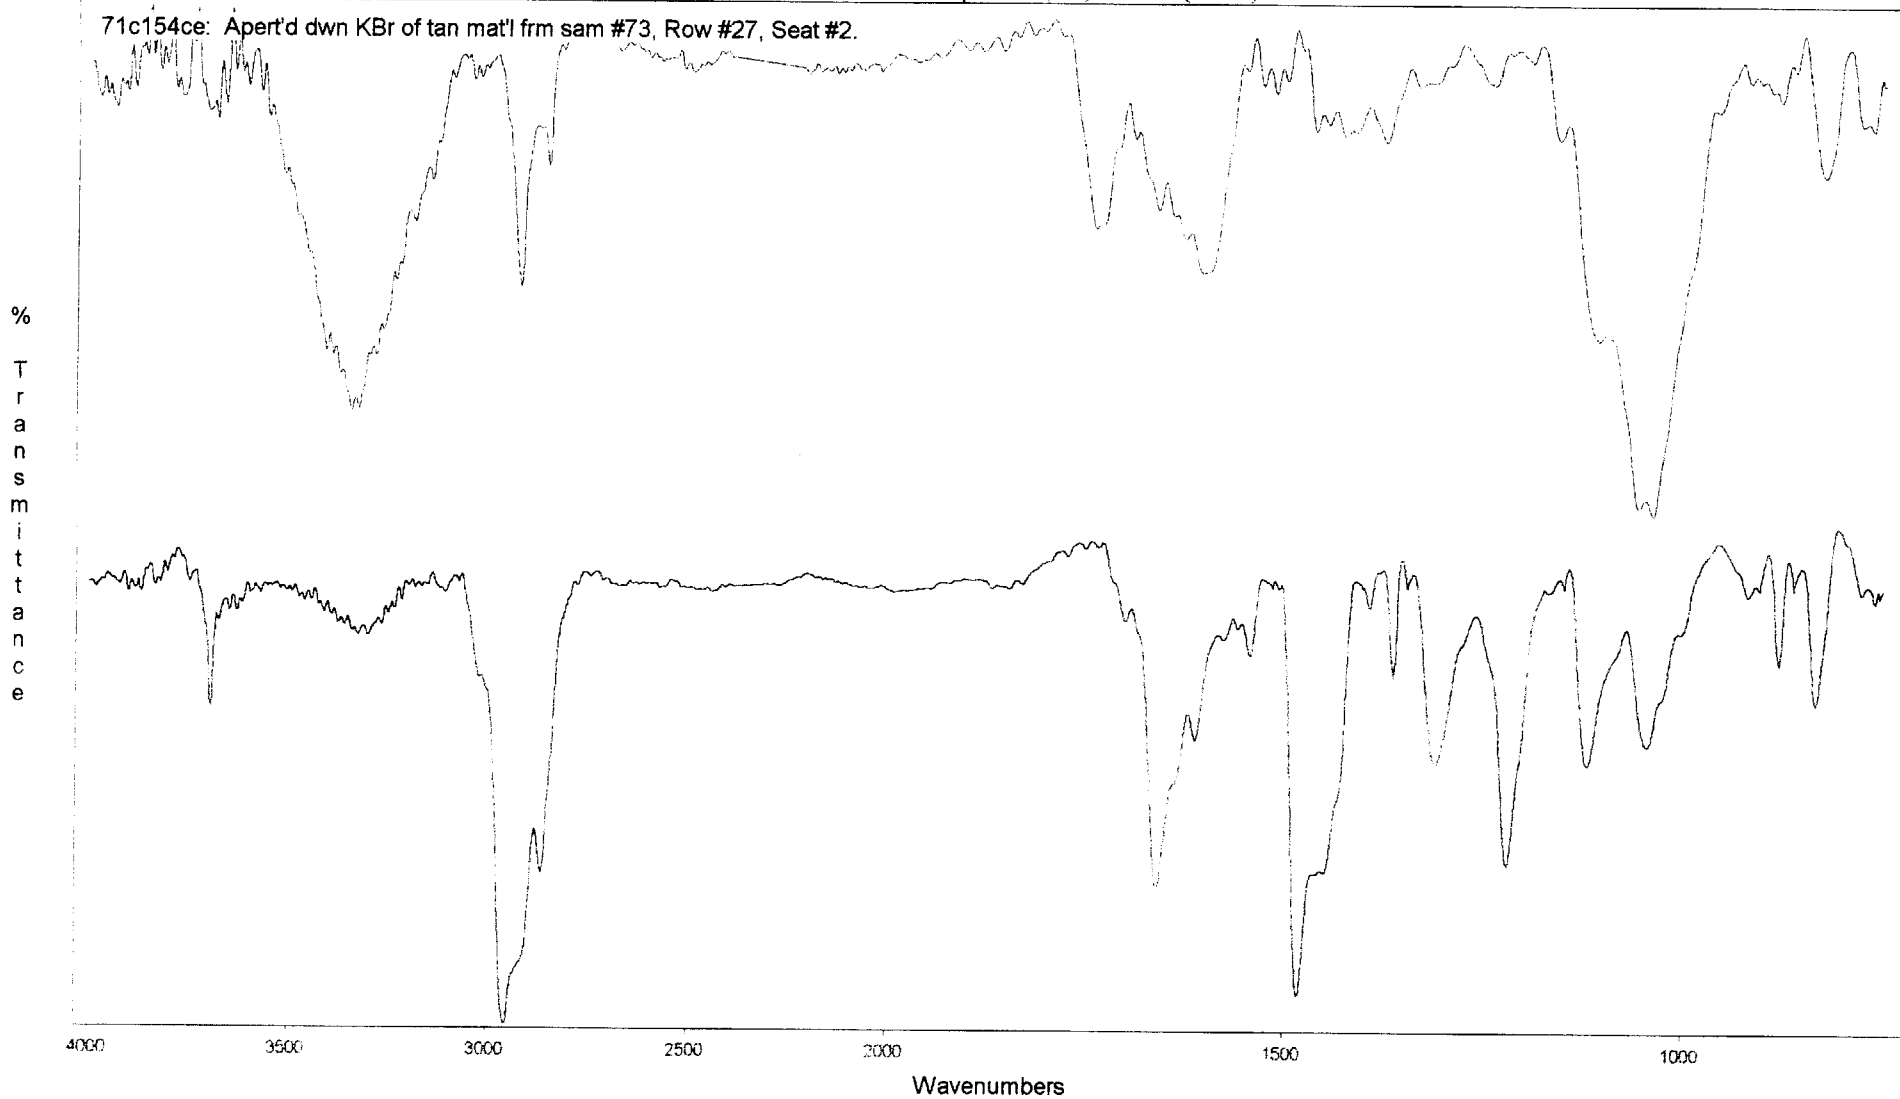
Figure 15. Spectral comparison of adhesive reference with contaminant of sample #73.

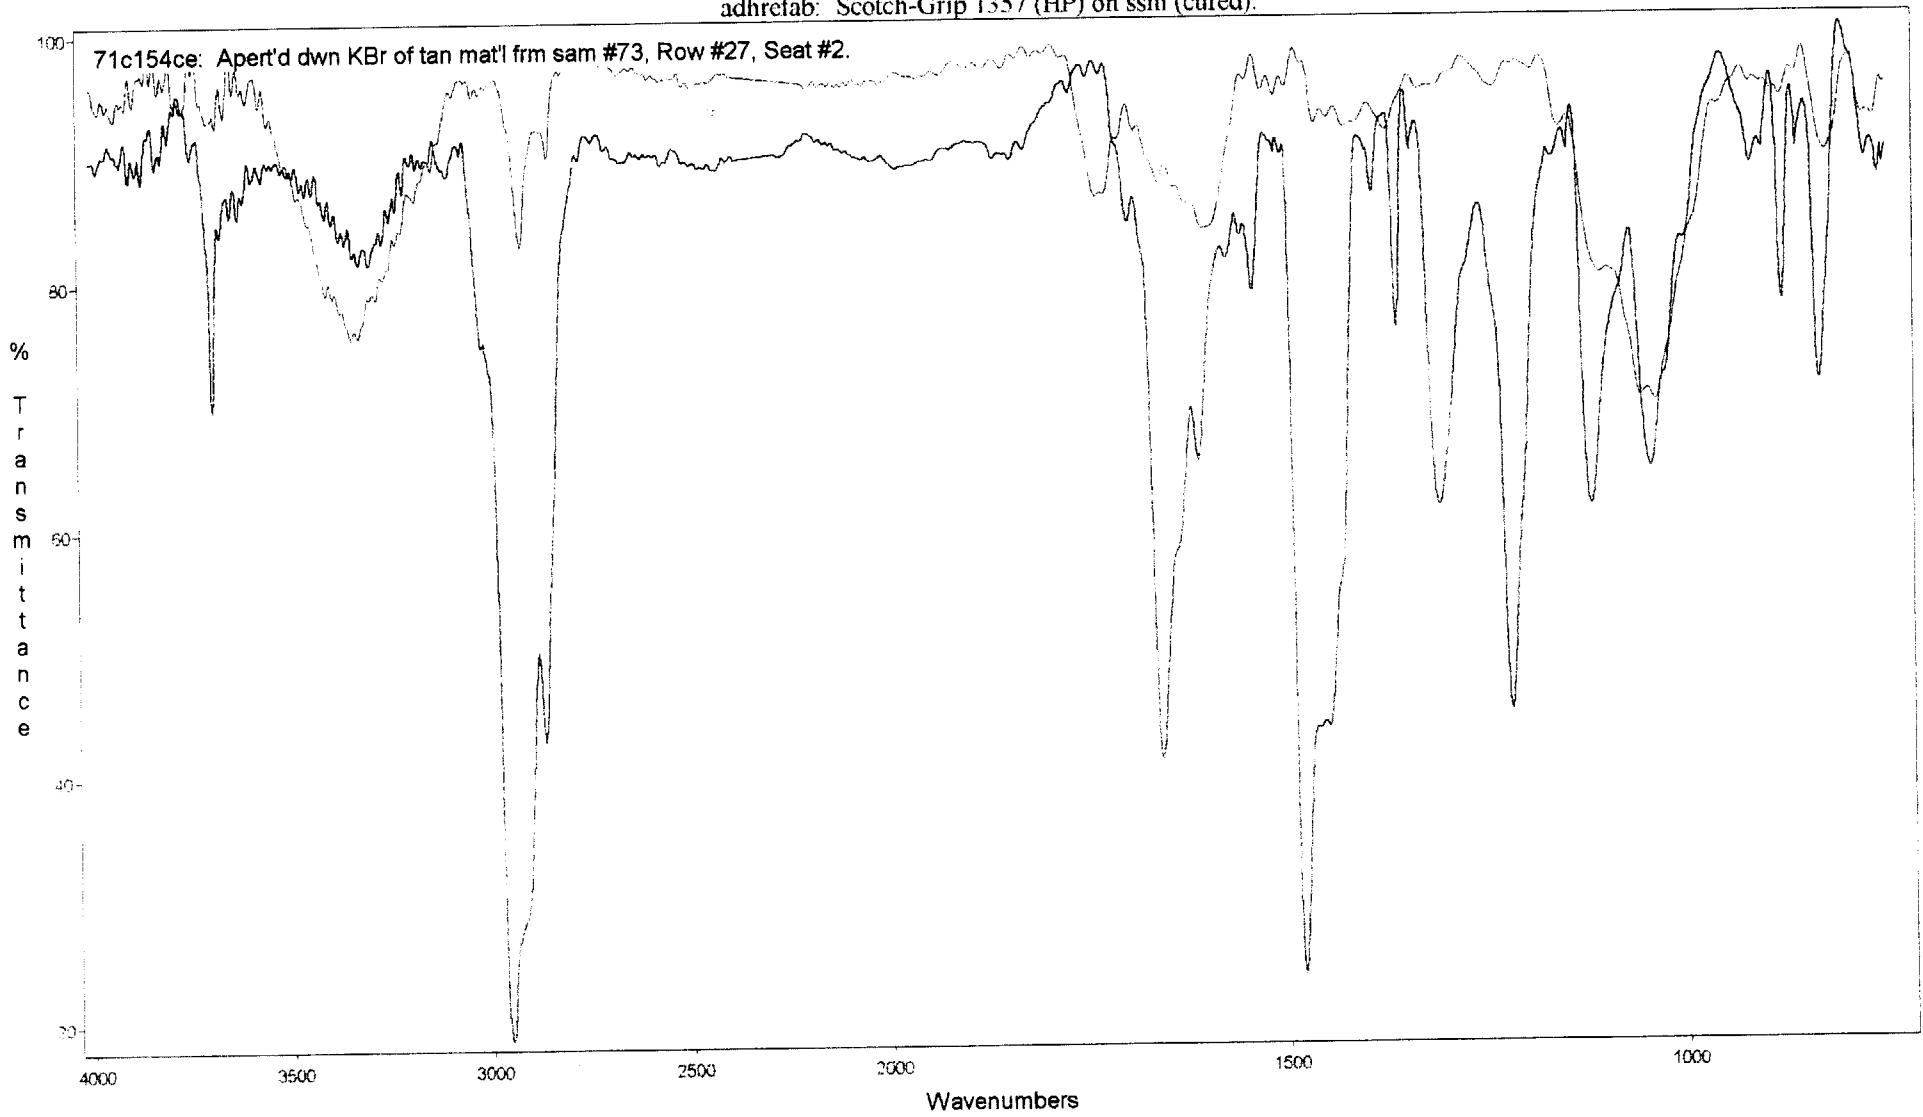
Figure 16. Spectral overlay of adhesive with contaminant.

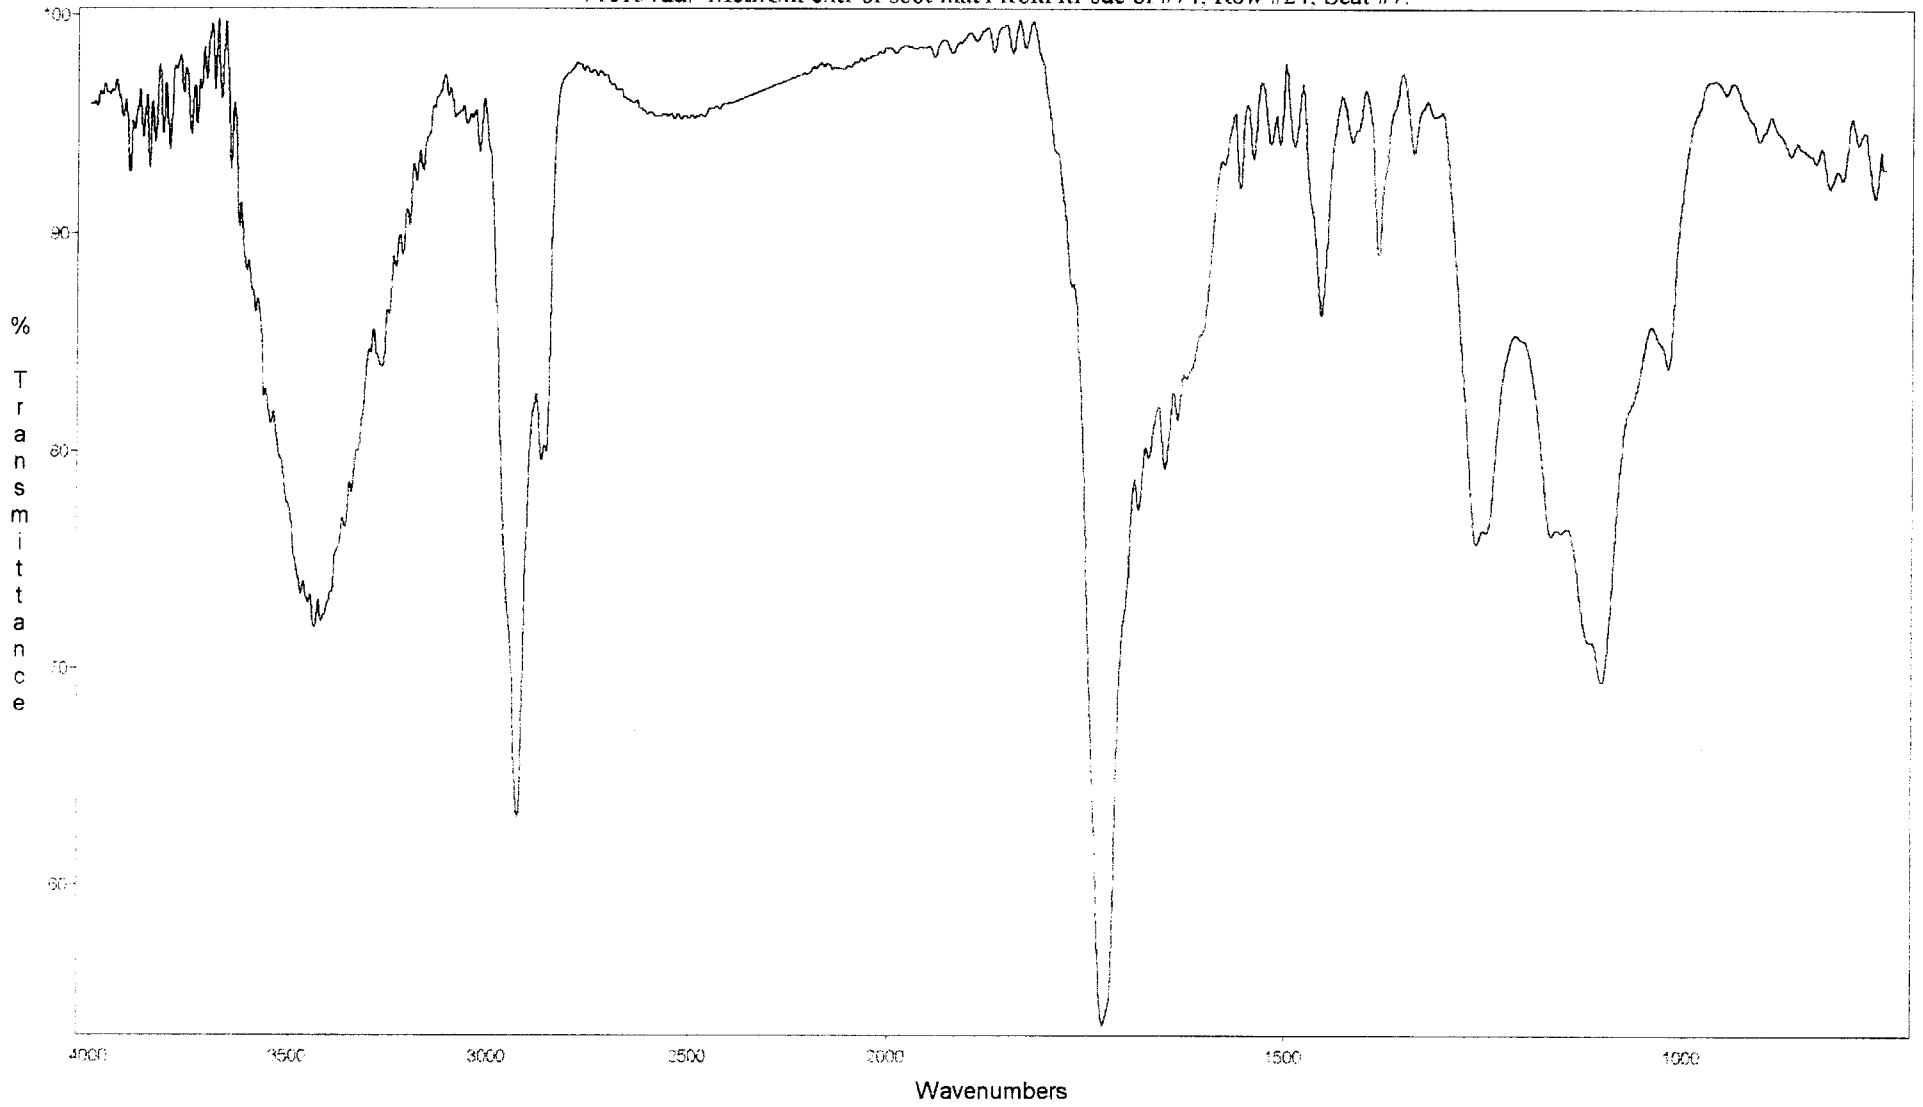
- 3.5 Sample #74, Row 24, Seat 7 (Figure 17) appeared to be a metal alloy (probably aluminum) and was characterized by charred material on both sides. Material from each side was removed and FTIR spectra generated. For the purposes of this discussion, the terms "darker side" and "lighter side" will be used to differentiate between the two sides. A gold colored glazed and a black organic appearing material were removed from the darker side and spectra generated. The FTIR spectra for each is provided in Figure 18 and Figure 19 respectively. From the lighter side, a "soot" looking material was extracted with an organic solvent and a spectrum generated. The spectrum is provided in Figure 20.

- 4.5 The gold glazed looking material removed from the darker side of sample #74, was identified as an acrylic polymer. The black looking material from the darker side of the metal was identified as a phthalate resin product, probably a Dacron™ filler. The presence of an anti-static agent was also detected. The same organic presence was observed on the lighter side of the metal sample although it was much less abundant. Since it is plausible to expect similar results from these materials, they were not examined further. There was a "soot" like substance present on this side that was not found on the previous side. This soot material was extracted, concentrated to dryness and analyzed. The IR data indicates that the major component of the "sooty" material is a zinc oxide which could be the oxidized phase of a zinc based polyvinyl chloride stabilizer.

Figure 20. Extraction of "sooty" material from lighter side of sample #74.
