DOCKET NO. **SA- 516**

**NATIONAL TRANSPORTATION SAFETY BOARD  
WASHINGTON, D.C.**

**ATTACHMENTS TO THE  
SYSTEMS GROUP CHAIRMAN'S FACTUAL  
REPORT OF INVESTIGATION**

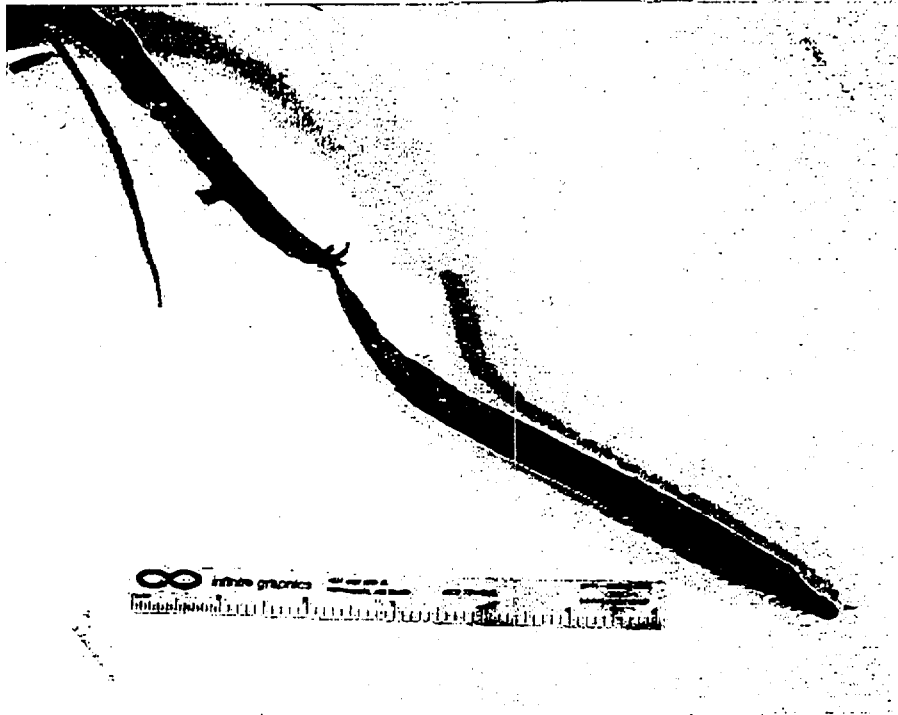
Figure 6. This is a close-up of the wiring in 5 Figure. The two melt areas on the copper wiring (middle and bottom) contained aluminum and confirmed that electrical arcing had taken place.

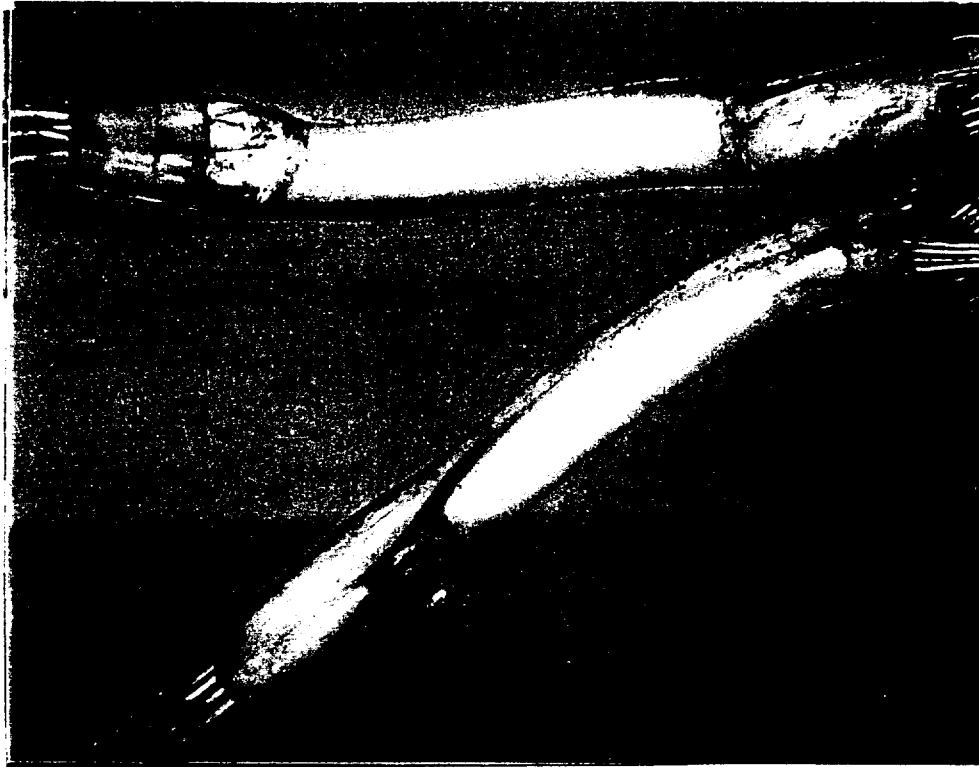
Figure 6. Sample one with high-Z wires separated. Note brown-black residues on the insulation. The residue forms a conductive path between the shield and signal wiring.

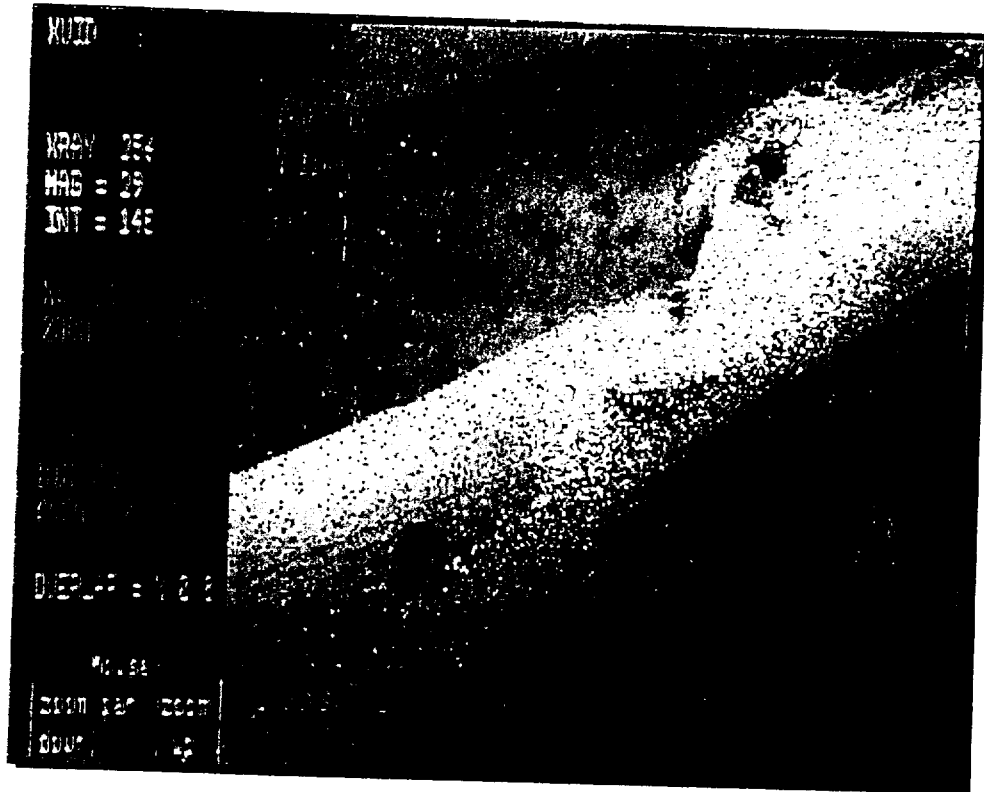
Figure 9. SEM back-scatter micrograph of the residue streak on the wiring showing the elemental distribution of copper (red) and sulfur (yellow). Note that the highest levels of the copper and sulfur coincide with the residue streak.

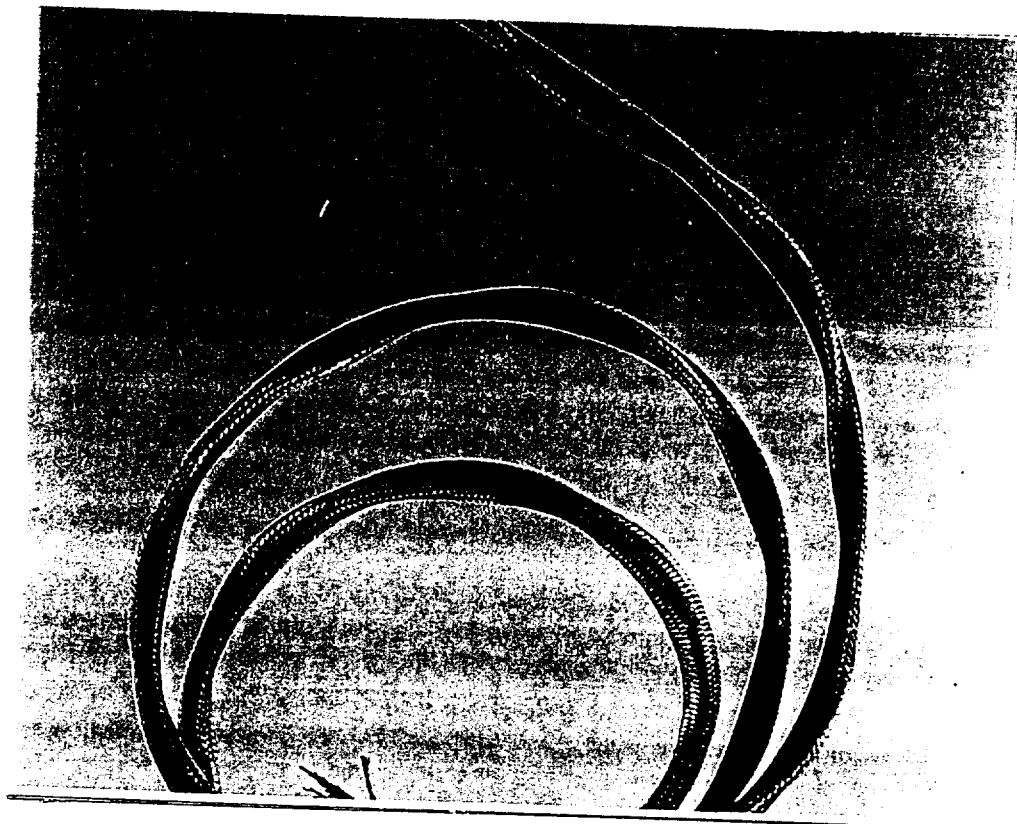
FIGURE 9. Fuel sensor cable blackening, K-329. Note that the black area corresponds to the shielded wiring only.  
Mag: 0.8X

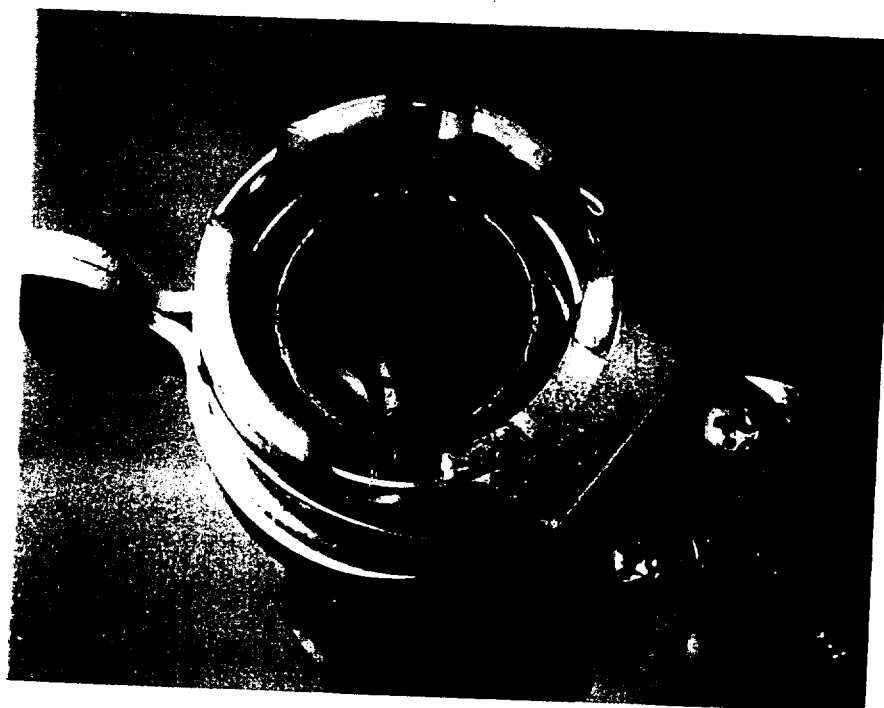
The strain relief cable housing at the top of the probe exhibited black deposits at the cable entrance (Figure 11). The cable housing was removed and inspected. The cable housing was chemically analyzed and identified as nylon. During the removal process, debris was removed from beneath the plastic clamps. X-ray elemental analysis identified the following elements: Al, Si, Ca, Fe, chlorine (Cl), cadmium (Cd), phosphorous (P), and Mg. A black deposit was noted where the cable came in contact with the housing (Figure 12). The black deposit was found to be conductive when probed with an ohmmeter (1 to 5 kilohms). X-ray elemental analysis of the black deposit is shown in Figure 13. The analyses identified S, silver (Ag), Fe and Cu. The wiring associated with the cable housing is shown in Figure 14. The blackened outer cable insulation was found to be slightly conductive. X-ray elemental analysis of the outer cable insulation is shown in Figure 15. The analysis detected S, Ag, and Cu. A black residue was also noted on the inner electrode of the probe (Figure 16). The area was found to be conductive and X-ray analysis identified S, Ag, and Cu. The area was found to be conductive and X-ray analysis identified S, Ag, and Cu (Figure 17). The terminals used to connect the outer and inner electrode to the cable wiring were also blackened and corroded (Figures 18 and 19). There was no evidence of electrical arcing in this area. A four point probe measurement was made on the outer electrode terminal. A value of 300 milliohms was obtained. The inner electrode was removed and examined for evidence of electrical arcing. The inner electrode appeared to be a Fiberglas material. The electrode was coated with a conductive film which, using X-ray elemental analysis, was identified as silver. The silver was protected with a phenolic coating. The edges of the electrode and other areas where the phenolic coating was damaged were blackened. The outer electrode was determined to be aluminum with an epoxy and iron oxide paint. The surface was nonconductive except where the black residue was previously noted.

FIGURE 10. Fuel sensor top clamp exhibiting blackened area, L-78. Mag: 1.4X

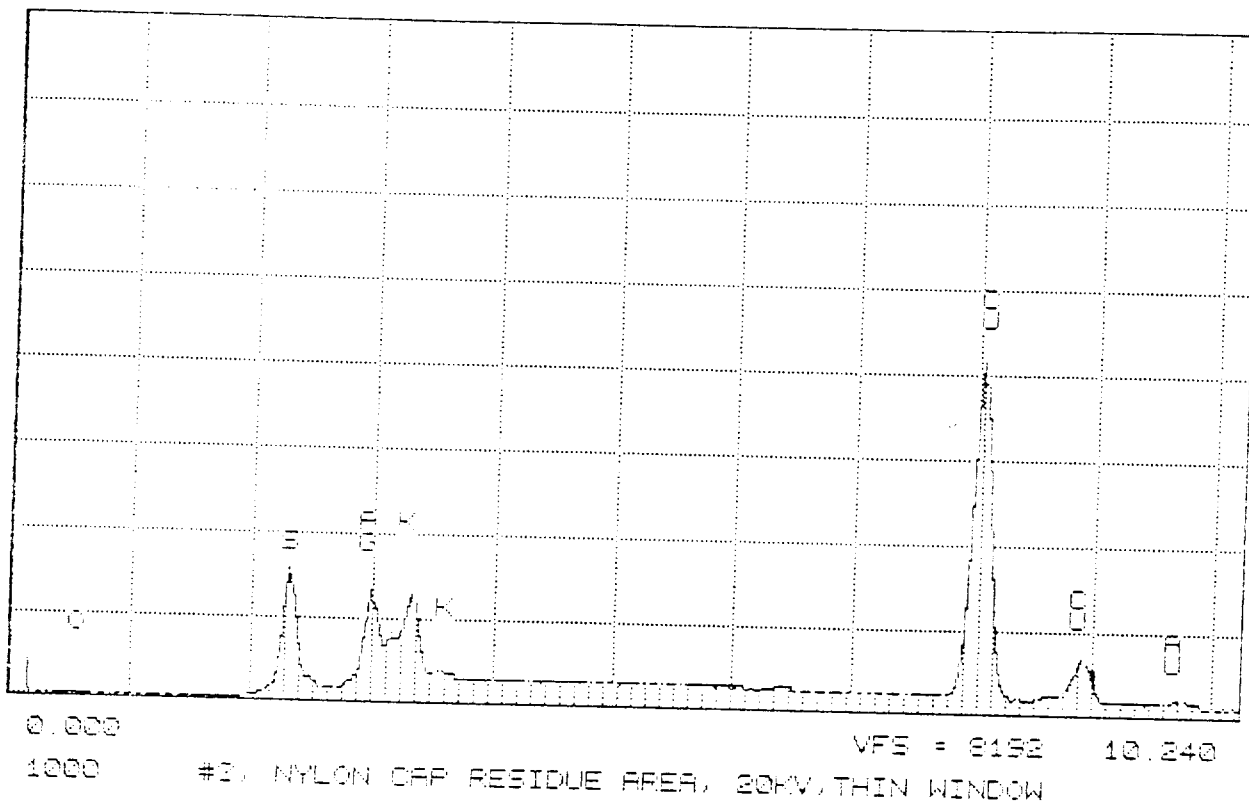
Each probe was disassembled and examined for surface residues or other anomalies. All probes exhibited black/gray residues on internal component surfaces in similar locations. The residues appeared to follow a path from the inner compensator electrode wiring to the nylon compensator support cap and to the outer electrode (Figure 6). Residues typically formed near exposed wiring or terminals (Figures 7 and 8). The residue on the wiring inside the clear Teflon tubing is shown in Figure 9. The center compensator electrodes for each of the four probes are shown in Figure 10. Note the residues appear to have washed down the side of the compensator plate. Electrically probing residues on various surfaces with an ohmmeter gave readings between 1K and 100K, depending on probe distances and residue build-up.

Figure 15. EDXS spectrum of residues on the nylon cap. Note presence of sulfur, silver, and copper. Areas outside of the residues did not contain these elements.

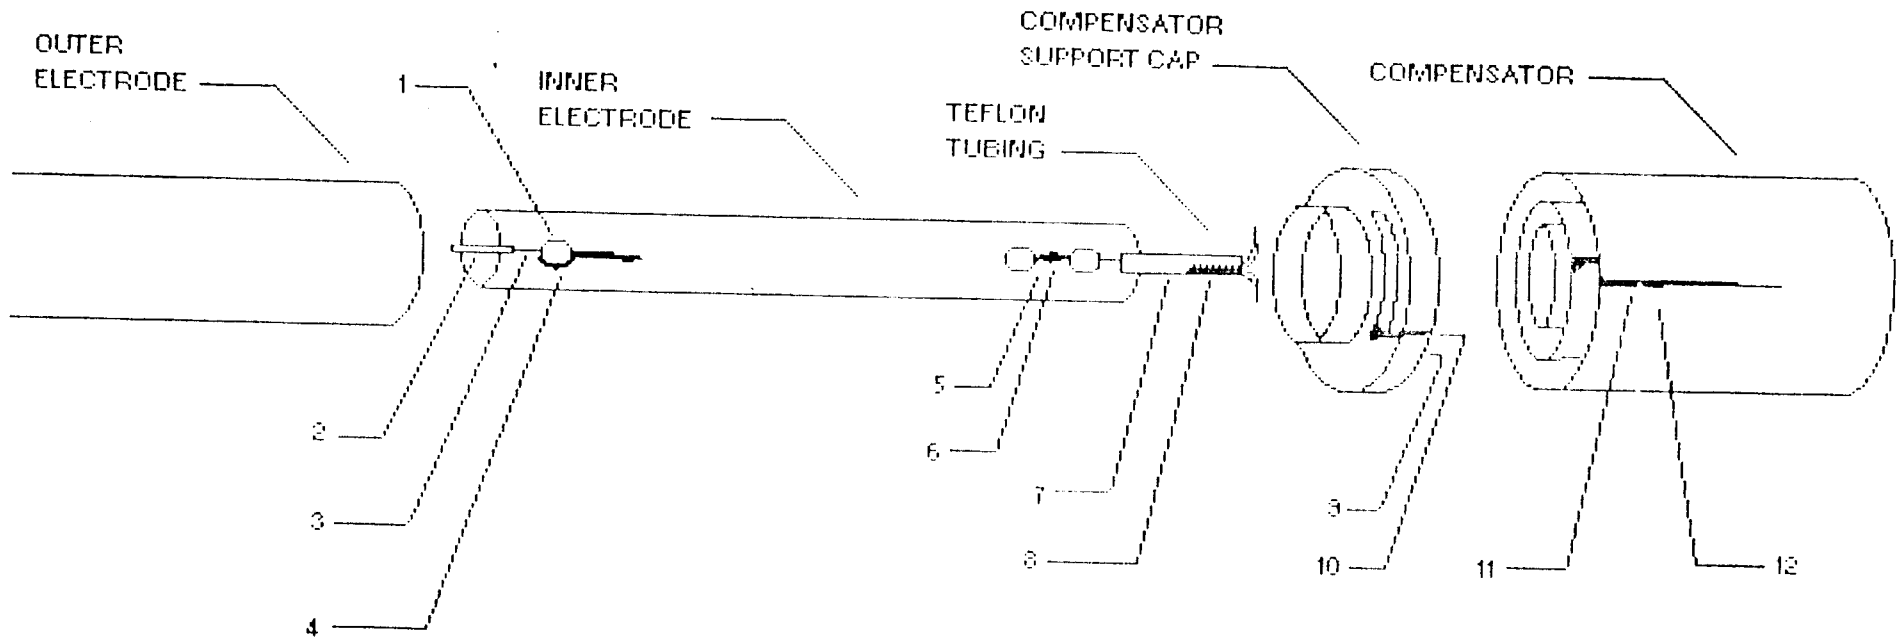
Figure 21. Summary of elemental analysis results for various probe components and residue locations.
