In accordance with the Board's rules, the Air Line Pilots Association (ALPA) submits the attached comments concerning the accident involving Trans World Airlines Flight 800, which occurred on July 17, 1996, off Long Island, New York.

**SUBMISSION OF THE
AIR LINE PILOTS ASSOCIATION
TO THE
NATIONAL TRANSPORTATION SAFETY BOARD
REGARDING THE ACCIDENT INVOLVING
TRANS WORLD AIRLINES FLIGHT 800
OFF LONG ISLAND, NEW YORK
ON JULY 17, 1996**

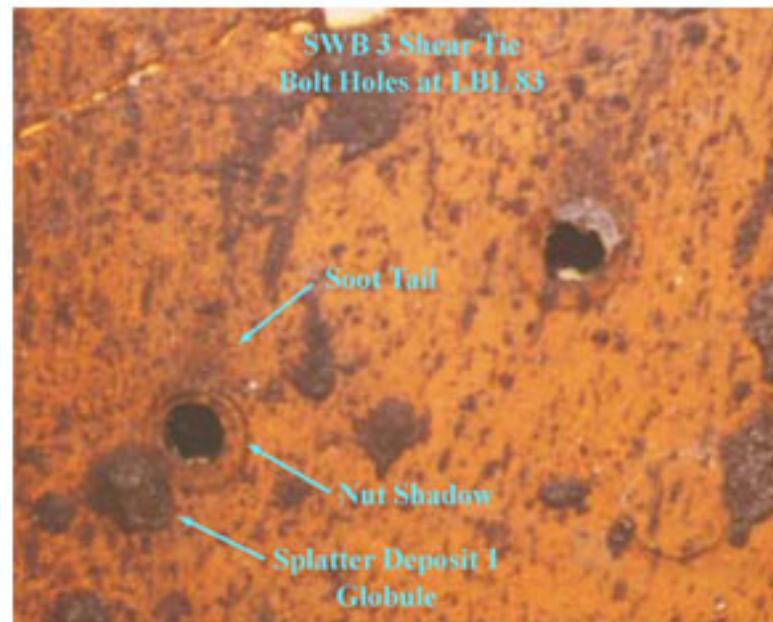
▲
Figure 8

On the upper skin, along the line of SWB 3, the holes left by the shear tie bolts are marked by small soot tails oriented forward. In some cases, particularly on the left side, it is clear that the nut which retains the shear tie bolt was still present when this soot adhered. In other cases, this is not clear. It is not possible to determine the disposition of each nut after SWB 3 failed; however, the violence of that event would likely have displaced the nuts as the shear tie bolts fractured beneath them. Thus, the pattern of this soot suggests that it may have adhered prior to the failure of SWB 3 (Figure 8).

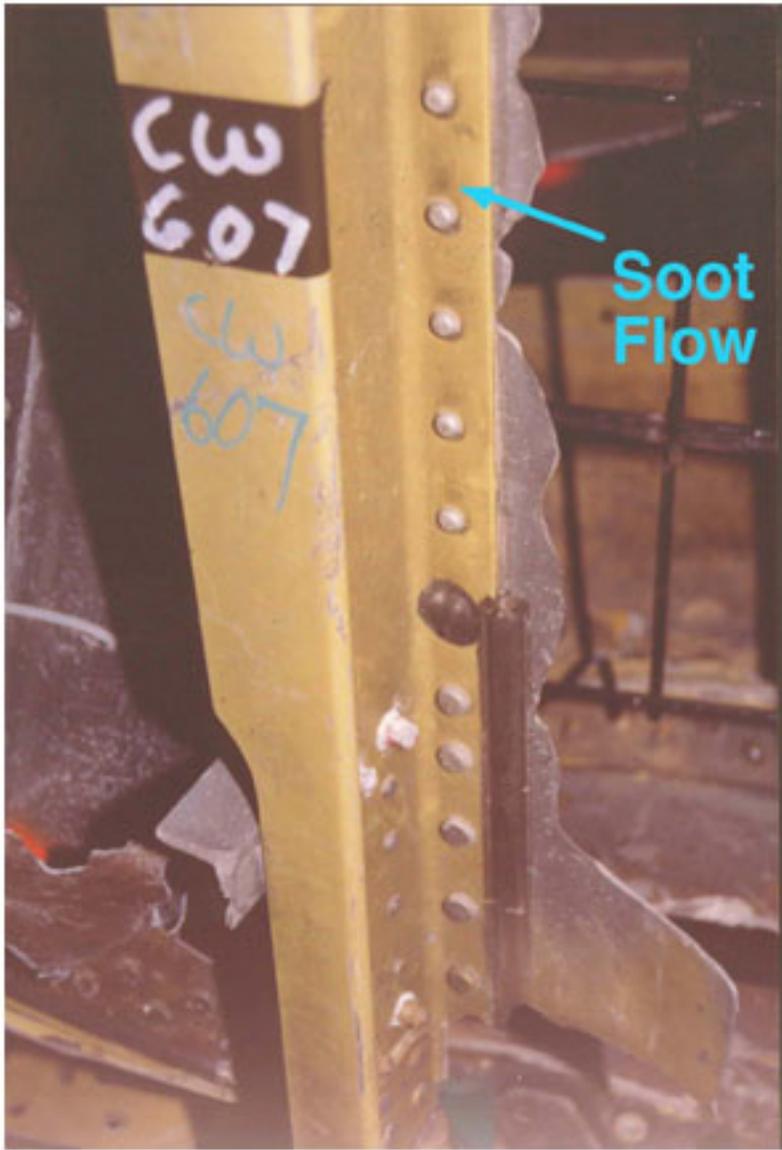
Figure 23

CW607 and CW633 comprise the recovered lengths of the stiffener at RBL 75. Both exhibit soot flowing upward on both sides of the stiffener web (Fig 23). The stiffener at LBL 75 exhibits very similar flow (Fig 24).
