NATIONAL TRANSPORTATION SAFETY BOARD

**SYSTEMS GROUP CHAIRMAN FACTUAL REPORT ADDENDUM
FOR AIRCRAFT WIRE INSPECTIONS AND HISTORICAL REPORTS**

A. **ACCIDENT:** DCA96MA070

Airplane : Boeing 747-131, N93119
Operated as Trans World Airlines (TWA) Flight 800

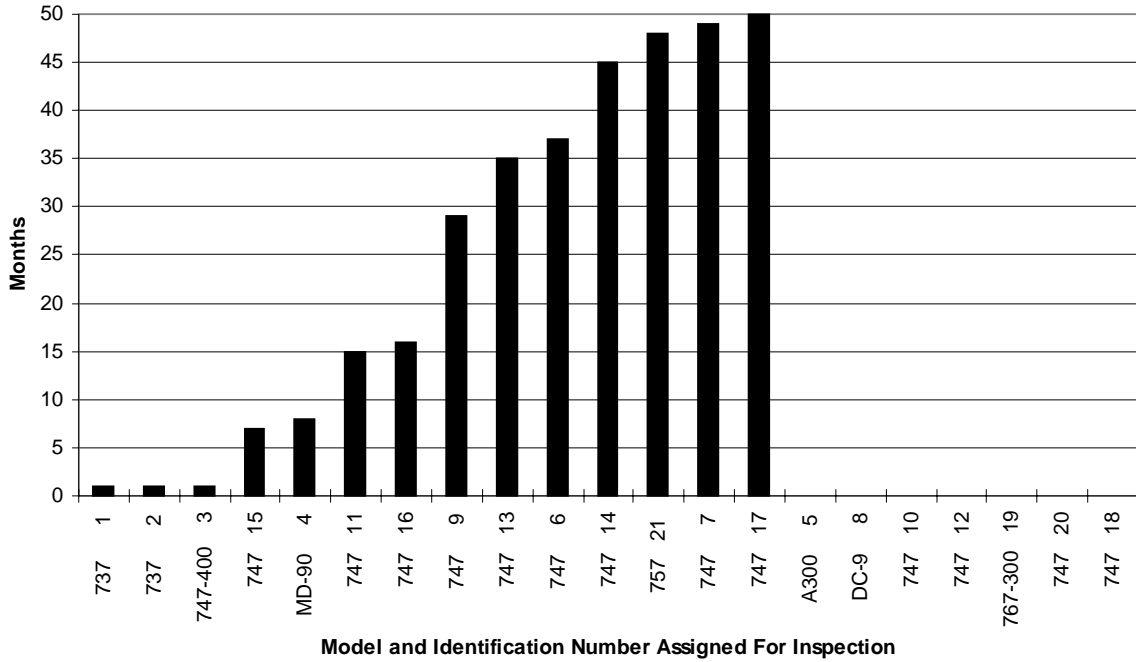
NTSB Wire Inspection Results Time Between D-Check and Last Flight

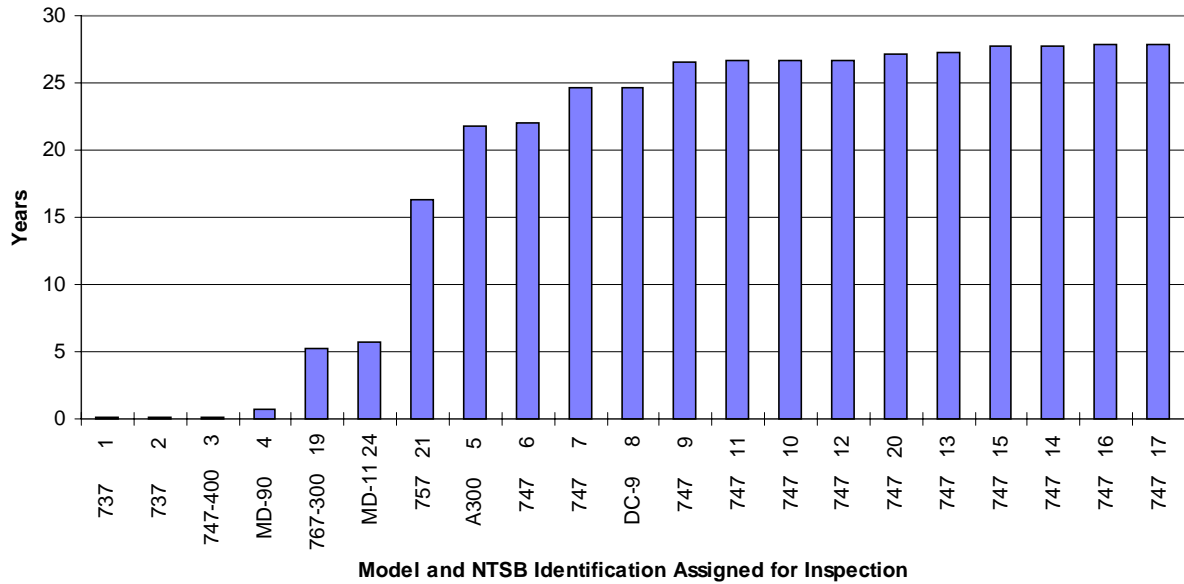
NTSB Wire Inspection Results Airplane Age When Inspected
