Aircraft Fuel System Safety Program Report

Prepared by the International Aviation Industry

August 4, 2000

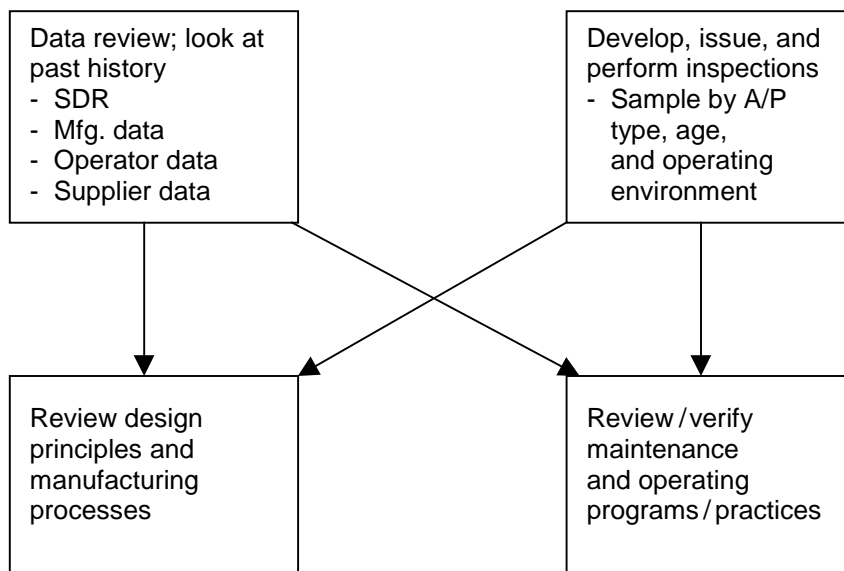
Figure 2-4: The AWG Process

Each manufacturer is the focal for its AWG and is responsible for coordinating these activities with its member airlines. The following diagram outlines the process that the AWGs incorporated into their individual fuel-system safety programs.

Initially, the airplane working groups were tasked to conduct a historical review of operator and manufacturer data related to fuel system findings. This review provided a list of “lessons learned” that could be applied in the design reviews and development of maintenance or operating instruction enhancements. Generally, a review of design principles and manufacturing processes was performed to develop or validate the inspection instructions for each model addressed by the AWG inspection programs.
