Aircraft Fuel System Safety Program Report

Prepared by the International Aviation Industry

August 4, 2000

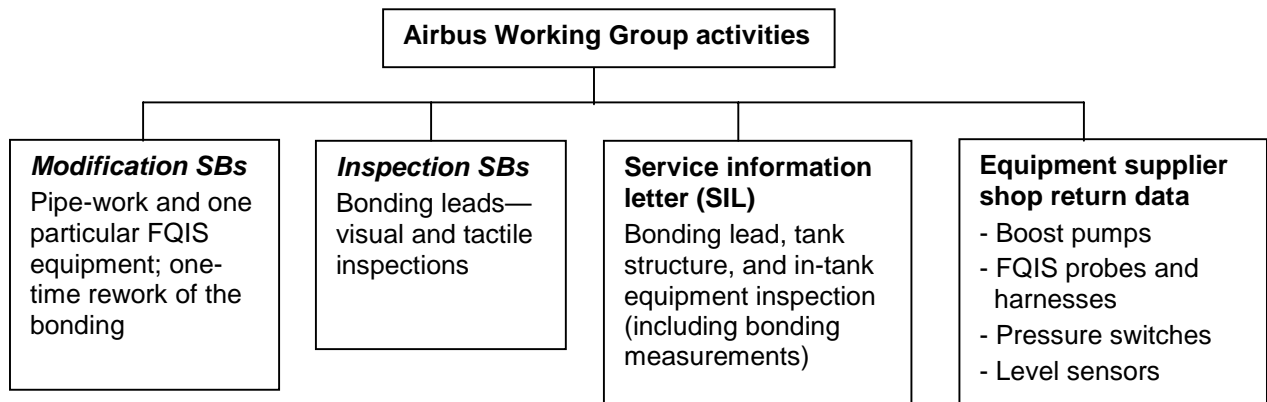
This chart shows the scope of activities and data gathering performed by the Airbus AWG:

3-2: Scope of Airbus Data Gathering
