## **EXHIBIT 20 - LOCATING THE MISSILE AIRBURST**

By William S. Donaldson Cmdr. USN Ret.

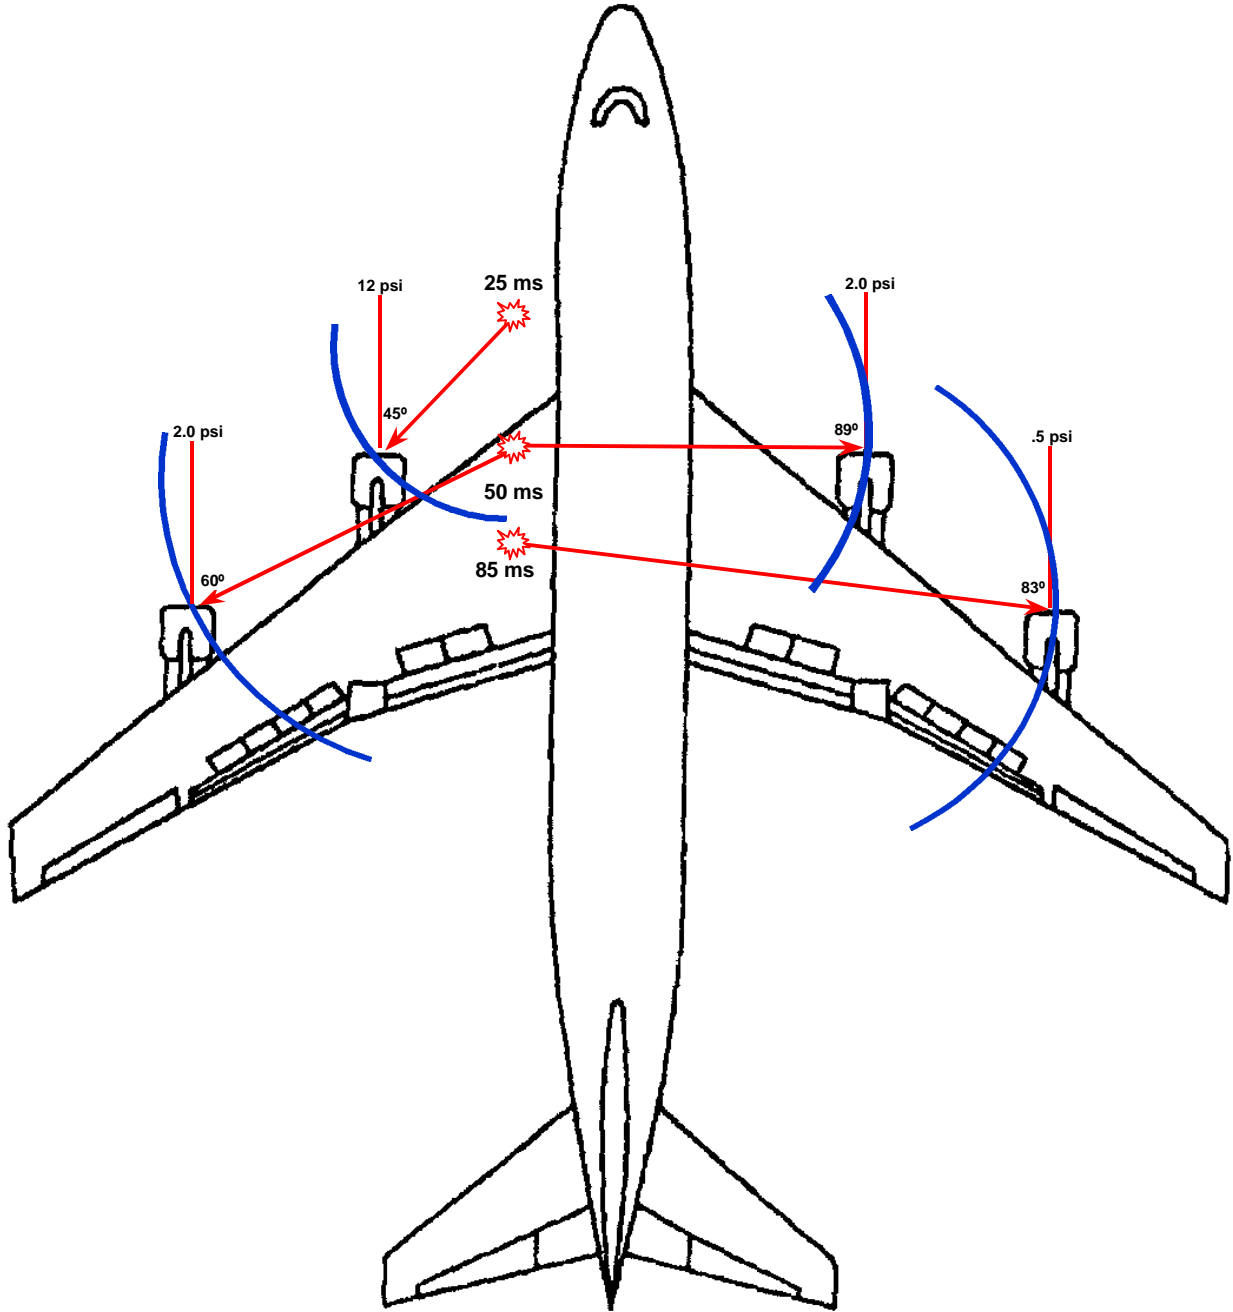
Airburst Shockwave impingement on wing and engines

5. Engine #2 is struck by shockwave first at 25 milliseconds after burst, 12 psi hitting from right side low on a 45° angle. See illustration on page 81.
6. Engine #1 is struck at 50 milliseconds after burst, 2.0 psi from right side, low on 60° angle.
7. Engine #3 is struck at 50 milliseconds after burst, 2.0 psi from left side, low on 89° angle.
8. Engine #4 is struck at 85 milliseconds after burst, .5 psi from left side, low on 83° angle.

This force was huge. TWA Flight 800’s wing area was 5500 ft<sup>2</sup> and wing loading about 103 lbs. per square foot. This means every square inch of wing was carrying .71 pounds. Now note on page 81 the 2psi asymmetric lifting force under the number one to the number three engines at 50 ms after the first airburst.
